# **LOW IMPACT STORMWATER PROJECT**

## **MADRID, SANTA FE COUNTY, NEW MEXICO**

April 2017

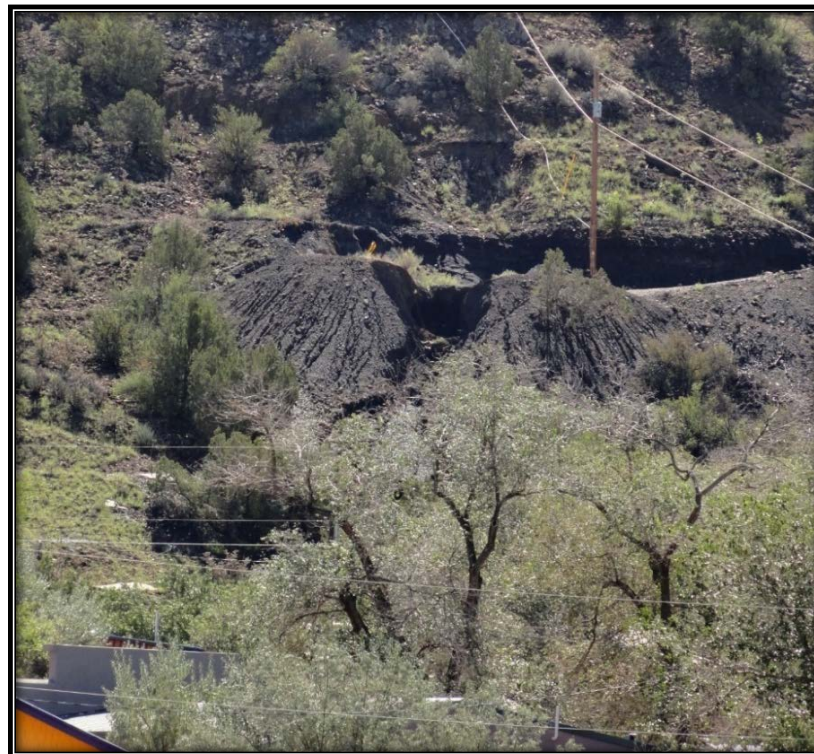
*Figure 4. Deeply eroded gob pile above Museum and Icehouse Road. Precast barriers were placed along the driveway above the gob pile to divert runoff to the upper drop inlet.*

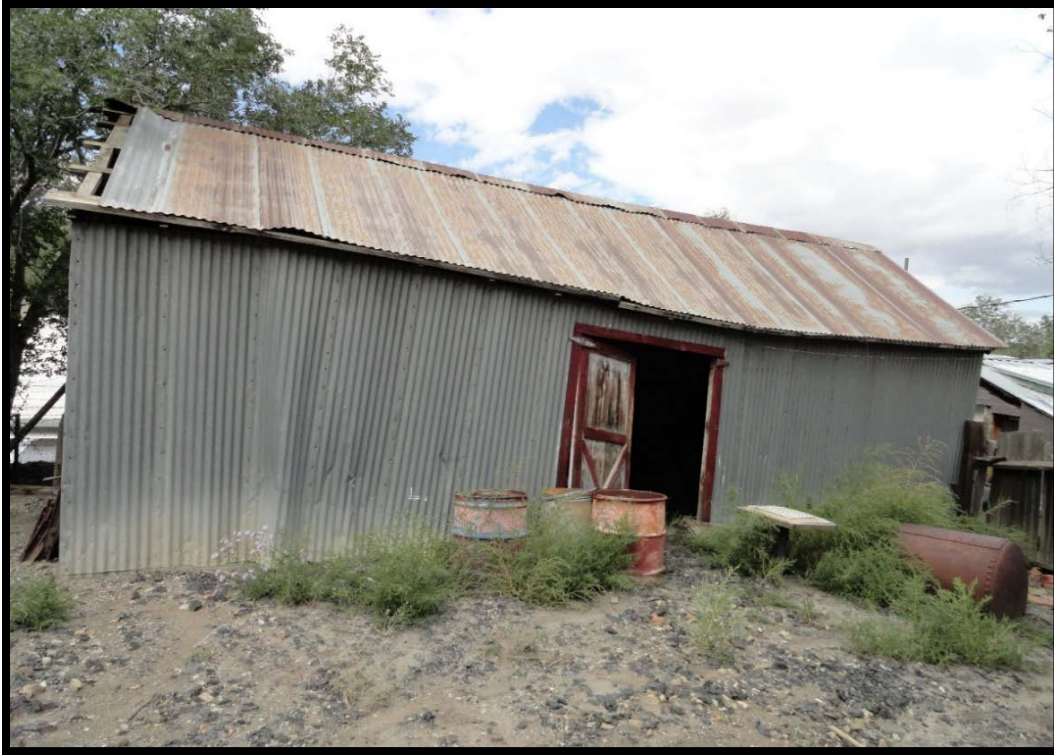
*Figure 5. Coal debris damage to historical Museum building below eroded gob pile*

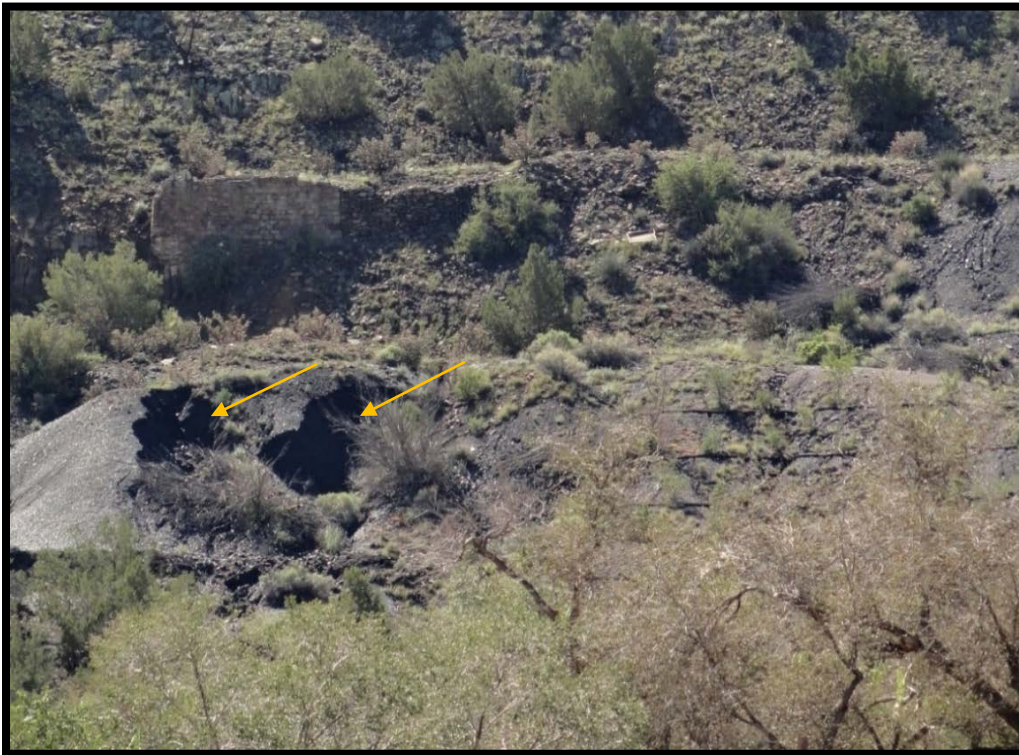
*Figure 6. Arrows indicate the newly blown-out gob pile above the Museum, September 2013.*

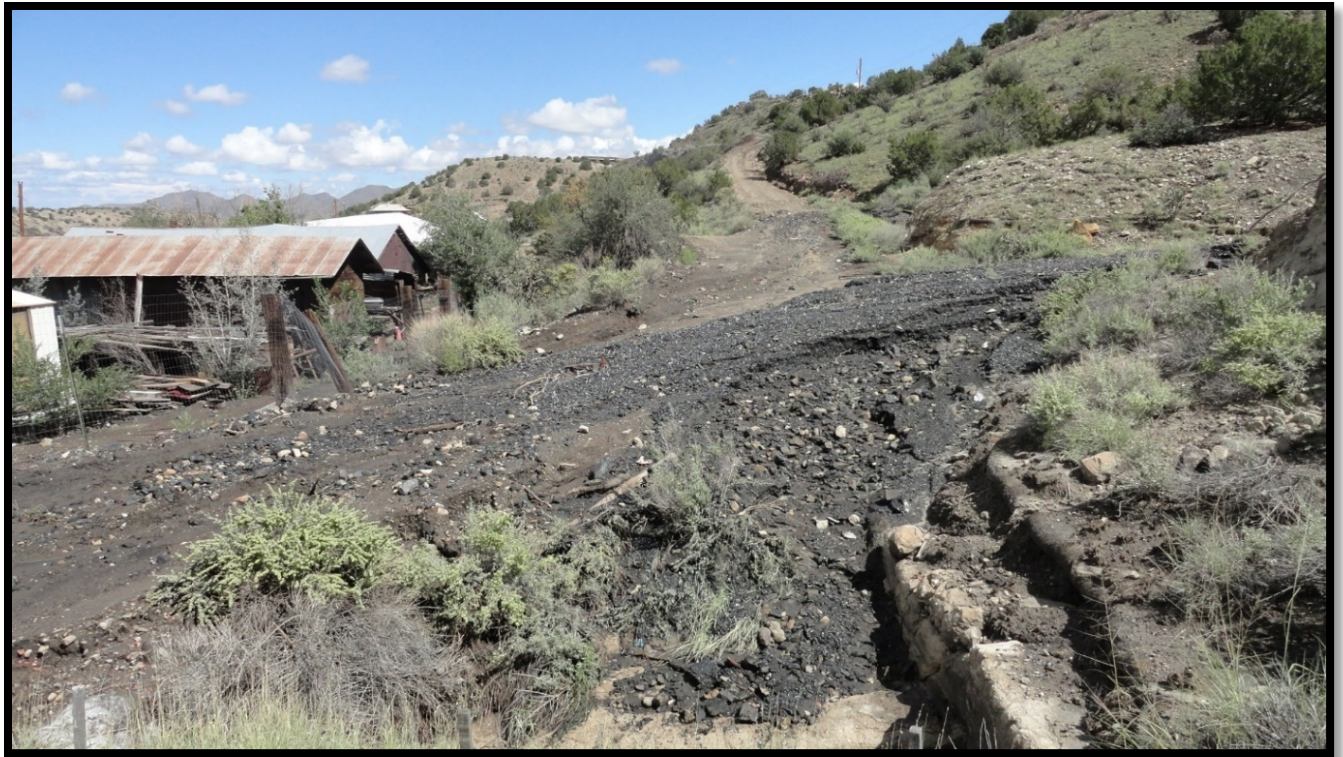
*Figure 7. Debris flow from gob blowout across driveway and onto Museum property, September 2013*

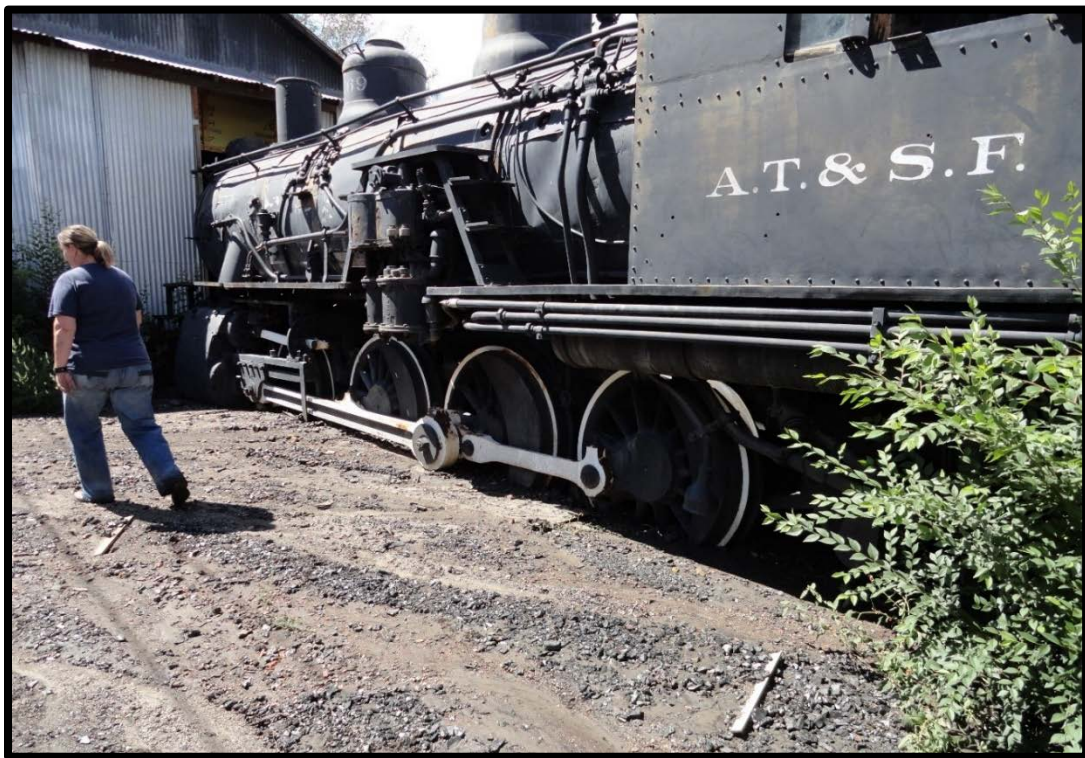
*Figure 8. Gob blowout debris build-up against steam locomotive at Museum, September 2013*

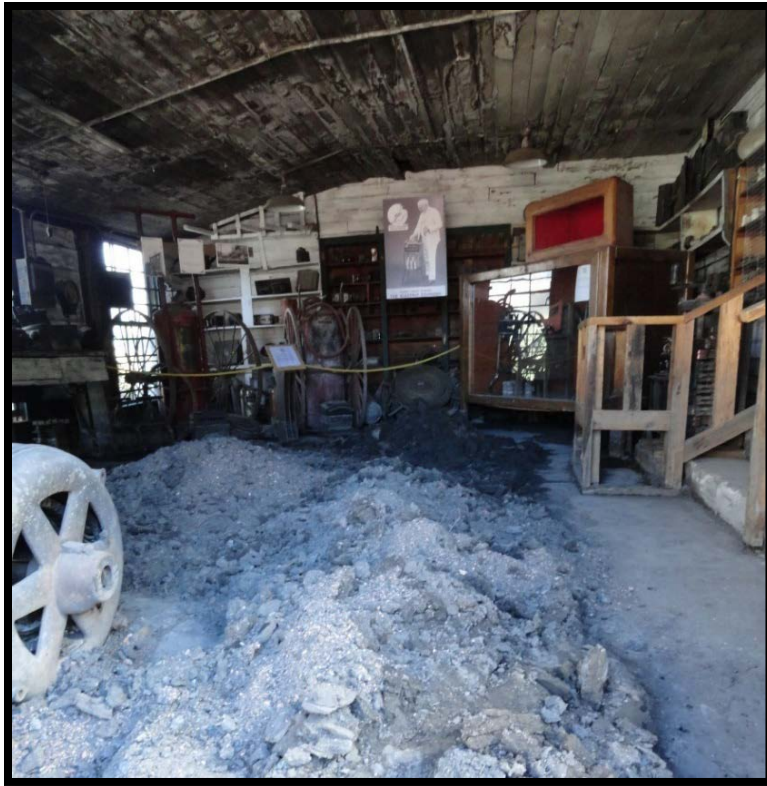
*Figure 9. Clean-up of gob blowout debris in a Museum building, September 2013*

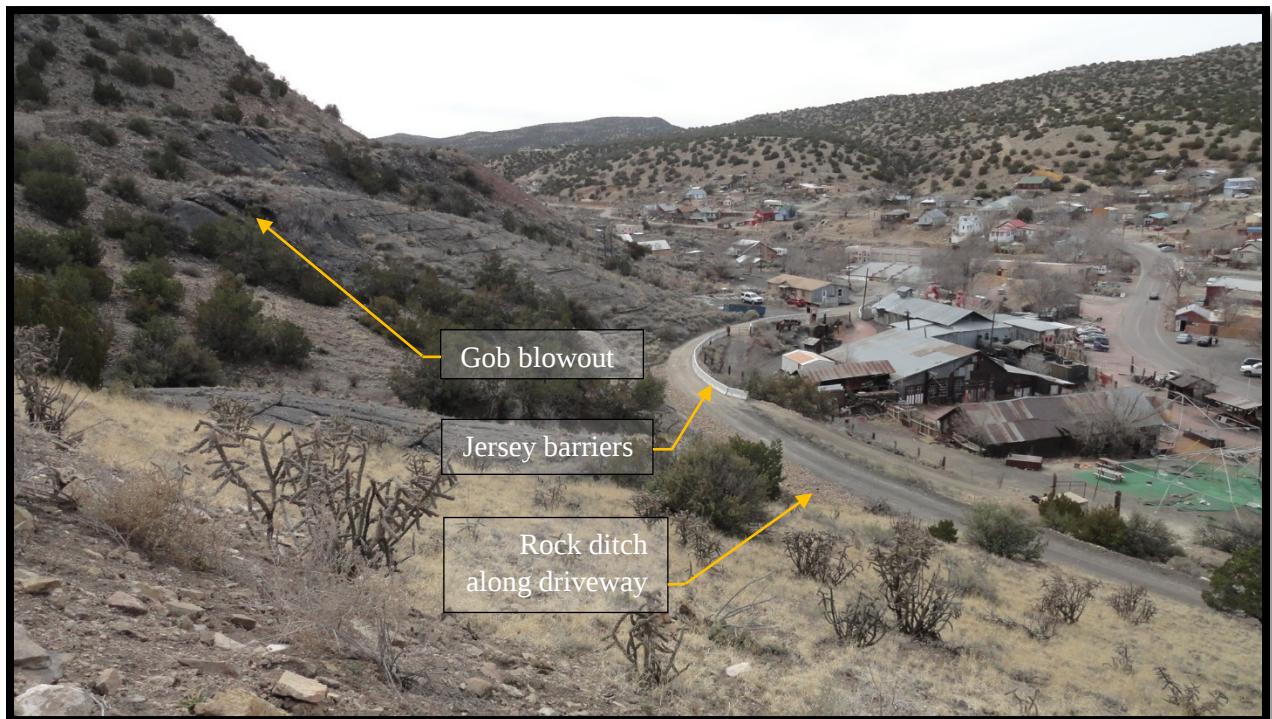
*Figure 10. Completed accelerated construction for temporary site protection with rock-lined ditch, base course on driveway, and temporary Jersey barriers above the Museum and State Road 14, October 2013*

Within two weeks, NMDOT mobilized to clear a clogged culvert and drop inlet along State Road 14 near the area of the blowout and, in early October, Rangeland began construction of immediate measures to protect public health, safety, and property. Measures included installing temporary protective Jersey barriers below the blown-out gob pile and above the Museum, installing other Jersey barriers at the head of a gob pile being deeply eroded by drainage off a nearby driveway, grading and installation of base course at driveways eroded by runoff from the gob piles, and rock lining of roadside ditches along portions of the driveways most impacted.

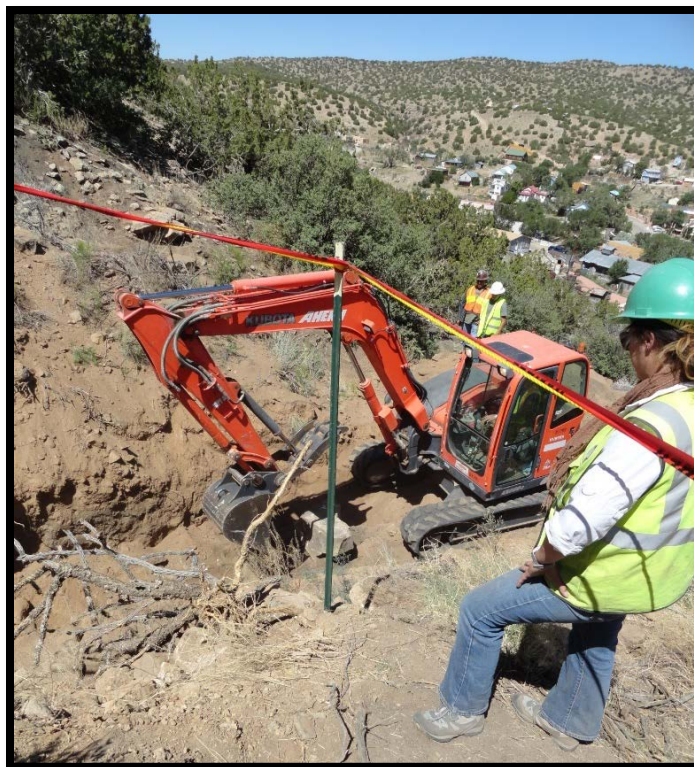
*Figure 11. Backfilling the Cranky Charlie Coal Mine adit, June 2014*

The Program and Rangeland then planned and executed more permanent measures. In June 2014, Rangeland remobilized equipment and crews to the site to construct rock channels on the hillside to divert stormwater around or to carry it safely across the gob piles above the Museum; to backfill an adit that had reopened in the area; and to further stabilize the gob piles with additional compost and mulch applications and planting and seeding of native species. Additionally, Rangeland constructed two types of innovative low rock barriers on the larger of two gob piles, one called "media lunas" (half-moons) and the other rock mulch rundowns,<sup>4</sup> both of which slow and infiltrate precipitation to aid in vegetation establishment and growth while armoring the surface against erosion.

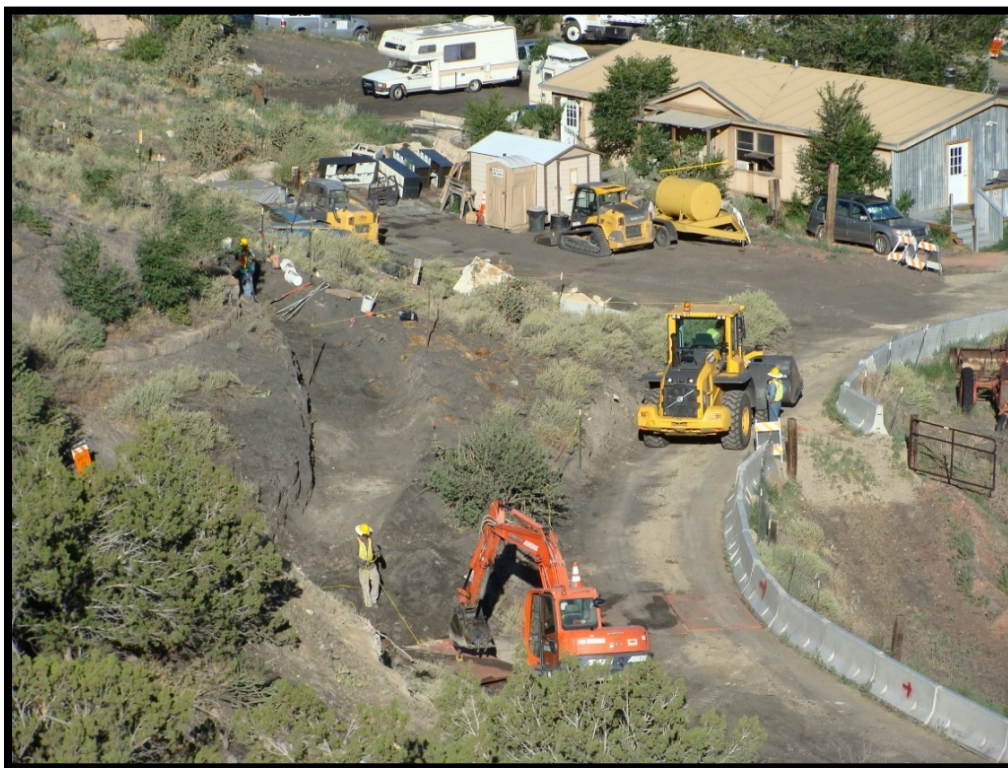
*Figure 12. Working in tight quarters to construct a rock bypass channel, July 2014*

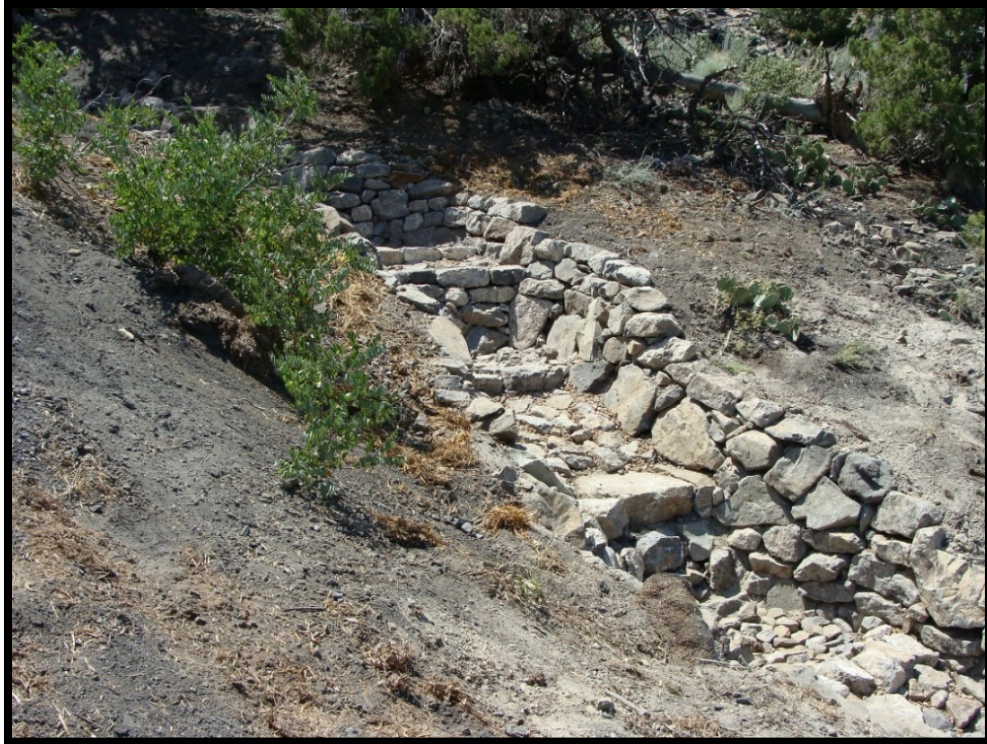
*Figure 13. Hand-built step-pool rock channel at edge of larger gob pile, July 2014*

The low rock barriers and rock channels were designed in place and installed by experienced operators and crews. Steeper rock channels were constructed as step-pool structures, which dissipate a portion of the water's kinetic energy at each drop. Additional rock ditches and rolling dips with rock-lined outlets were constructed along the adjacent driveway for erosion control and stormwater conveyance. Over eight hundred one-gallon sized native seedlings were planted to stabilize the channels and gob piles.<sup>5</sup>

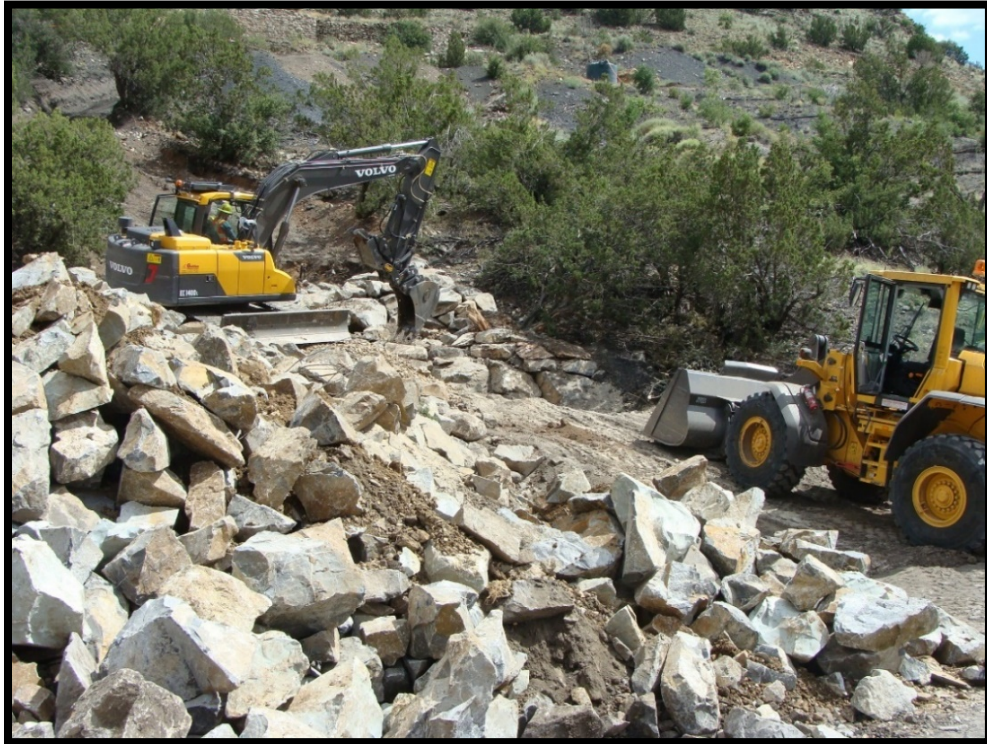
*Figure 14. Constructing a machine-built, step-pool rock bypass channel around blown-out gob pile, July 2014*

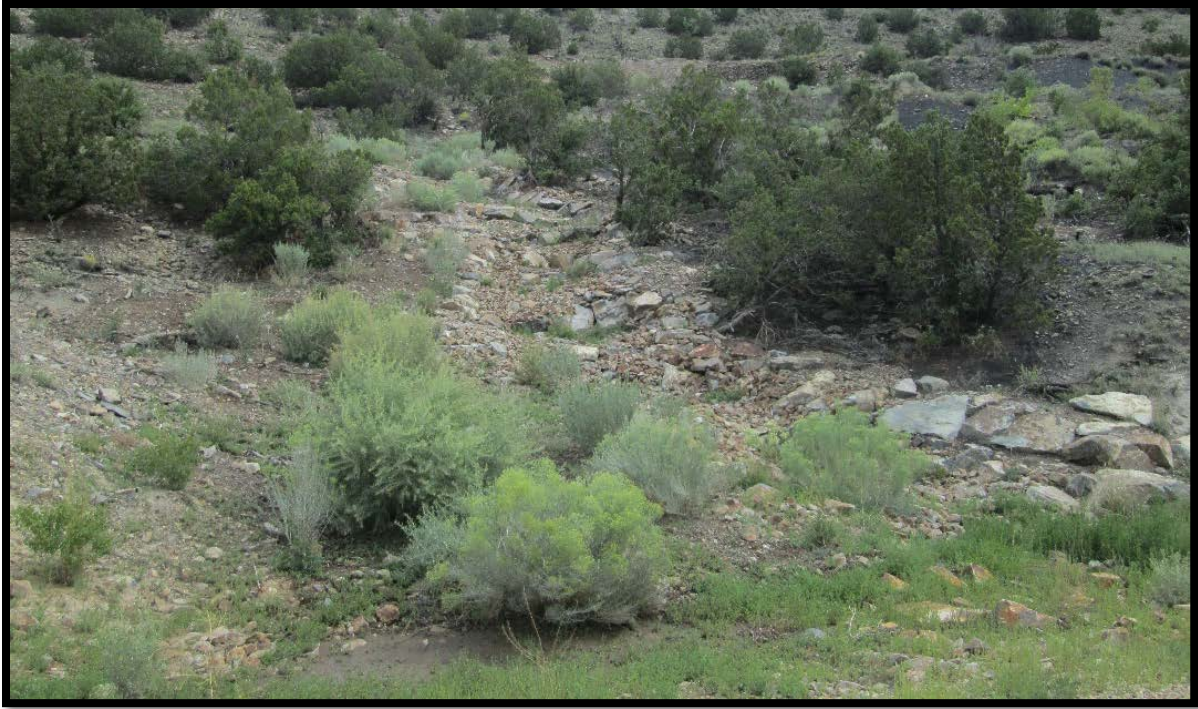
**Figure 15.** The completed step-pool rock bypass channel in August 2016. Note planted and seeded vegetation in and around the channel. The large light colored rock was covered with smaller tan rock to better blend channels into the surroundings.

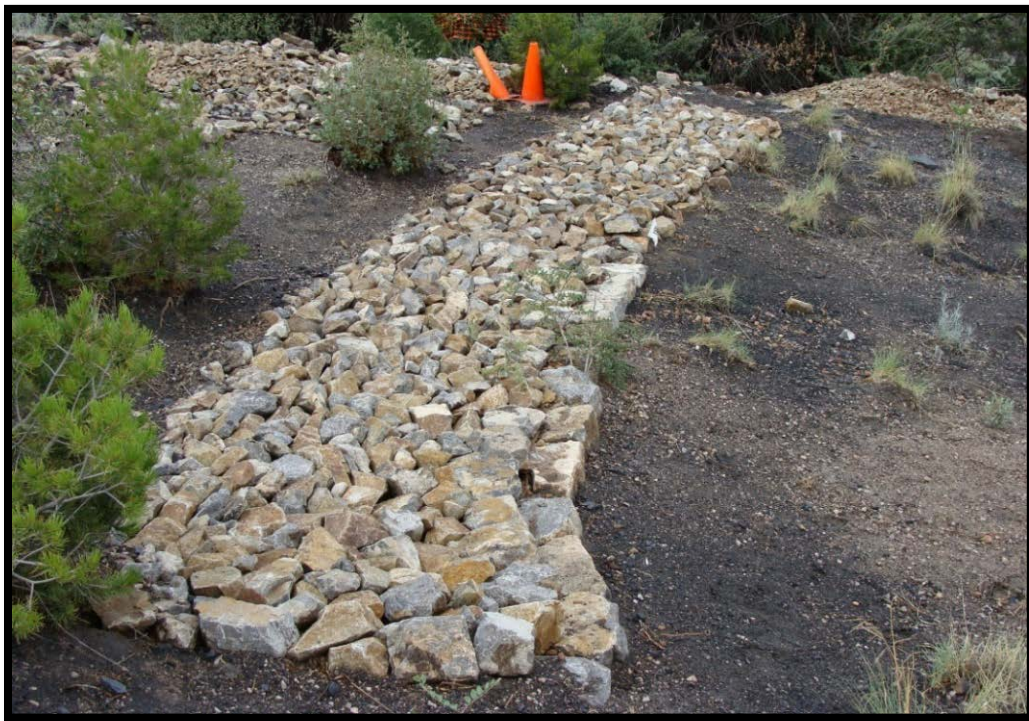
**Figure 16.** Newly constructed rock media luna on the larger gob pile to collect sheet flow, slow and infiltrate it, and direct it toward a rock mulch rundown below.

<sup>4</sup> Information on and drawings and photos of media lunas and rock mulch rundowns are found at: [http://www.watershedartisans.com/Erosion\\_Control\\_Field\\_Guide.pdf](http://www.watershedartisans.com/Erosion_Control_Field_Guide.pdf). See Figure 16 below for a photo of a media luna installed in the project.

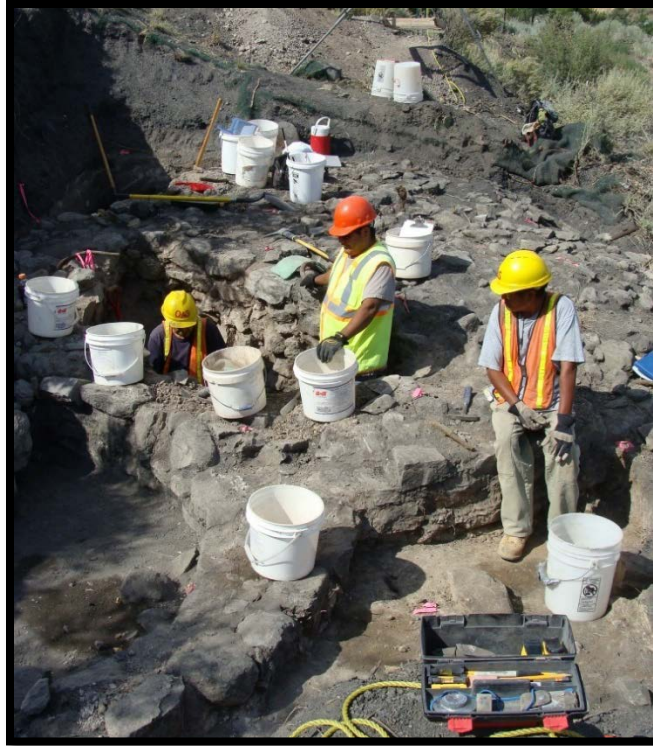
*Figure 17. Archaeological excavation underway during construction, July 2014*

During construction of improvements to drainage and gob stabilization on the hillslope, archaeologists monitored all activities. While constructing a rock channel to direct flows to an existing upper drop inlet, a rock structure dating back to the mining era was uncovered, so construction was temporarily halted in the immediate area, and the site excavated and recorded.

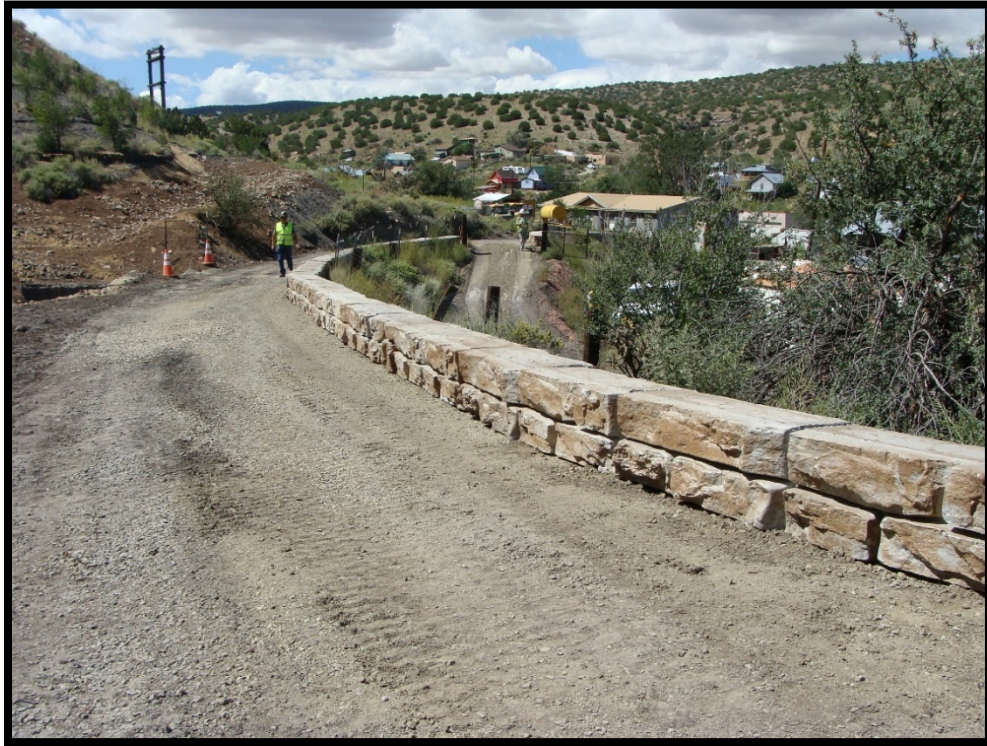
*Figure 18. Precast architectural blocks for stormwater control, replacing temporary Jersey barriers, September 2014*

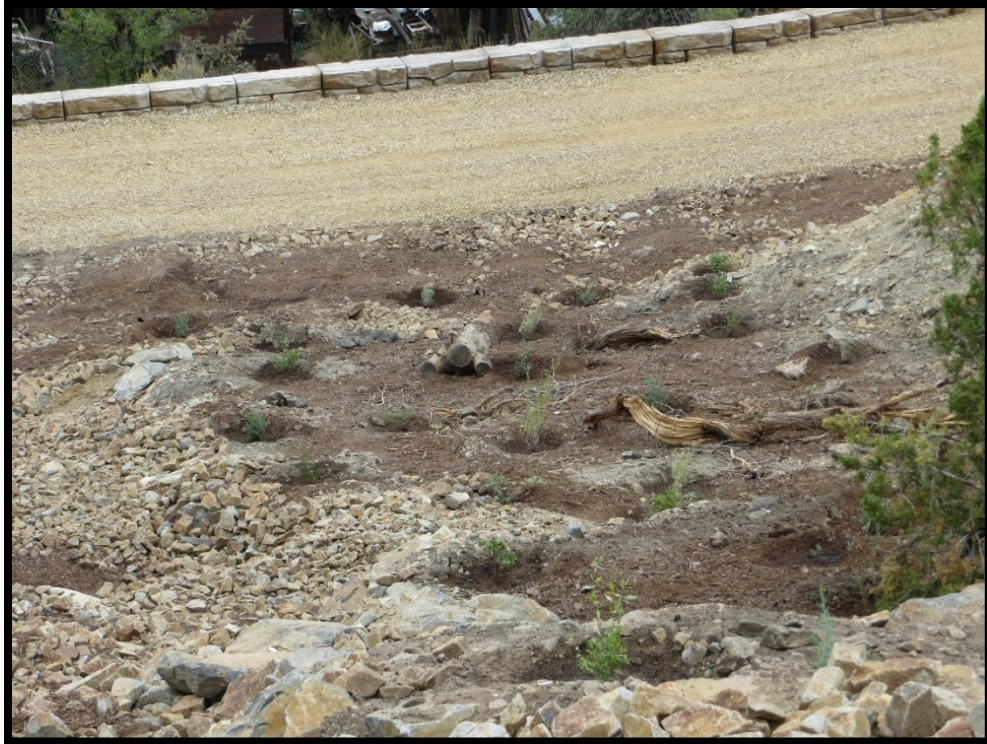
*Figure 19. Newly planted native seedlings for slope stabilization, October 2014*

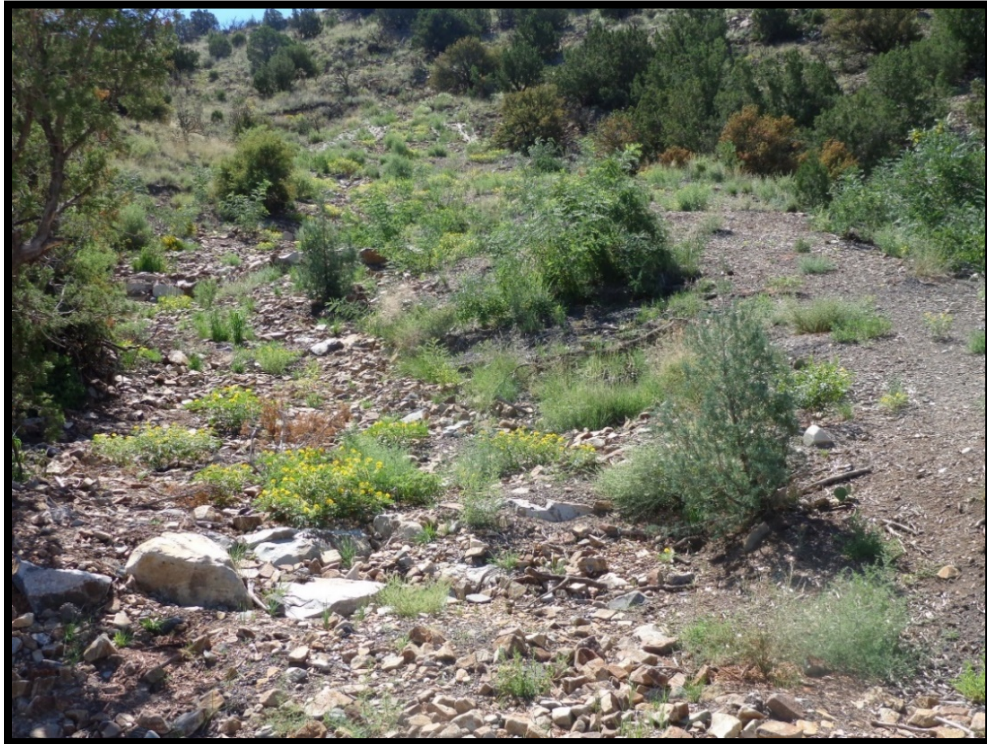
*Figure 20. Rock diversion channel on left and smaller reclaimed gob pile on right one year after construction, August 2015*

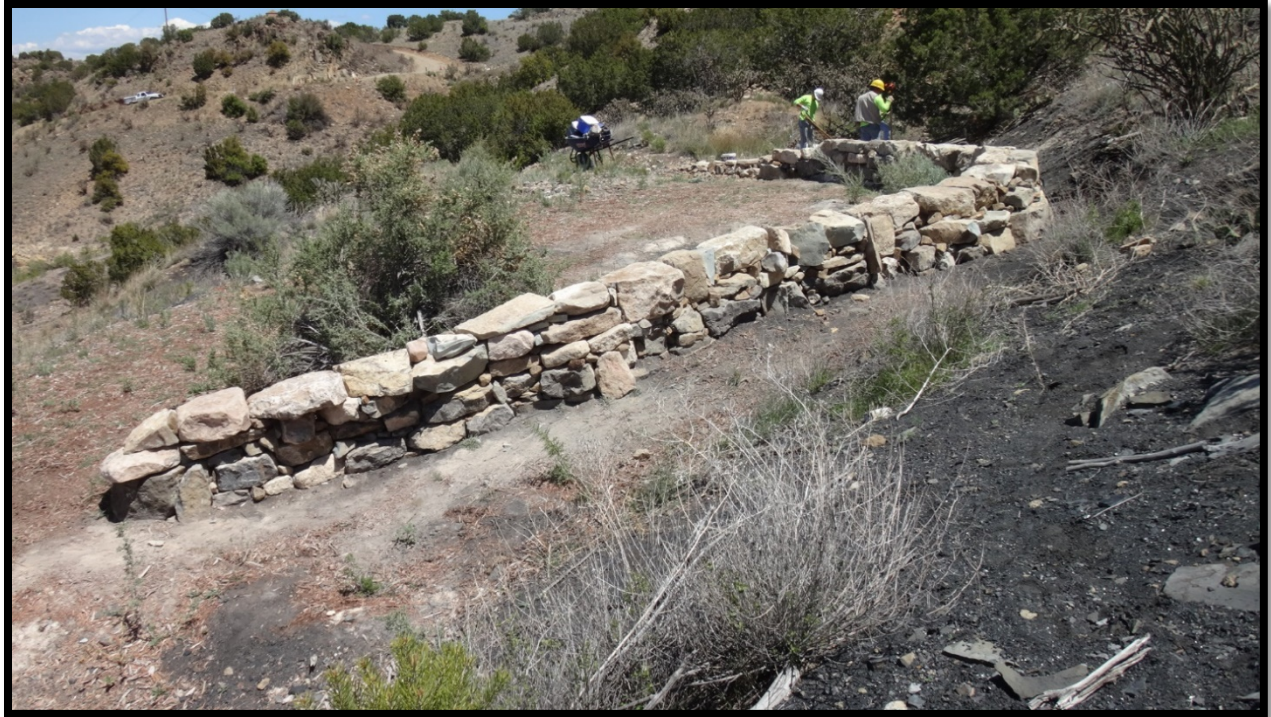
**Figure 21.** Raising of the dry stack rock wall to divert hillslope stormflows around the top of the larger reclaimed gob pile, May 2016

The contract with Rangeland included any needed maintenance on their work within the four-year contract period. In 2016 the AML Program determined that the dry stack rock wall built at the top of the larger gob pile to divert storm drainage around it needed to be raised. Sediment buildup from a small unreclaimed gob pile above it threatened to overtop the wall. This work was completed in May and has been the only maintenance work needed to date.

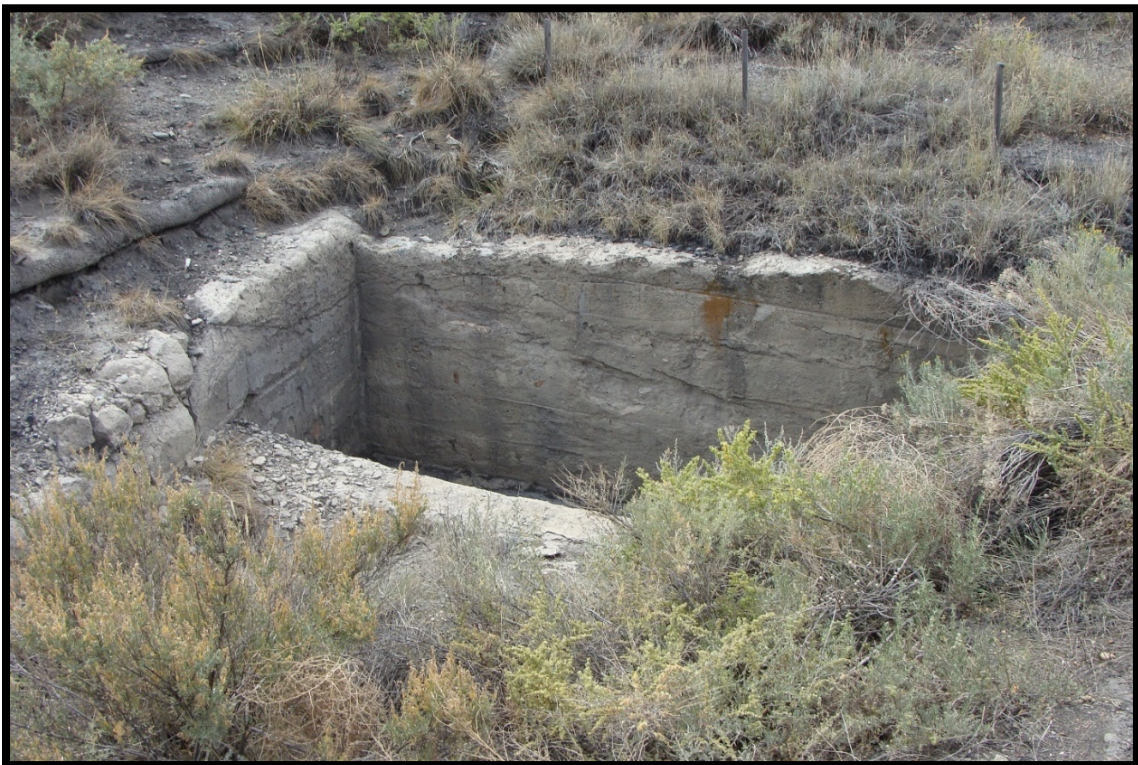
**Figure 22.** The derelict upper drop inlet below the gob piles and above the Museum before construction

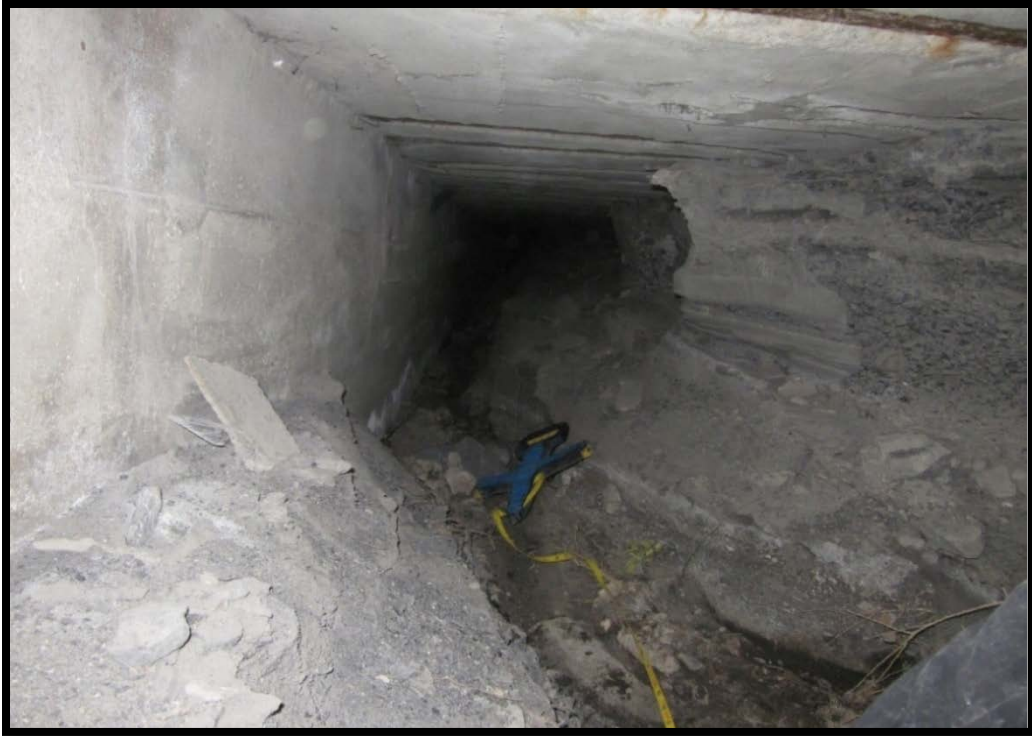
them underneath a couple of the Museum buildings and the Mine Shaft Tavern in a derelict four-foot square concrete box culvert to a more recently constructed NMDOT drop inlet in front of the Tavern. Examination of the box culvert indicated that it was severely clogged with mining debris. The box culvert also often completely clogged just above it necked down to a 24-inch diameter pipe in front of the Tavern.

**Figure 23.** Storm box culvert below the upper drop inlet, clogged with coal mine waste debris before permanent reconstruction through sliplining

Beginning in February 2015 (a time of year negotiated with nearby shop and restaurant owners to minimize business impacts), Rangeland and its subcontractor, AUI Inc. sliplined the box culvert with a continuous, 36-inch diameter, smooth barrel steel pipe; removed the section of 24-inch pipe in front of the Tavern and replaced it with a 36-inch diameter pipe connected to the NMDOT drop inlet; reconstructed the upper drop inlet (using the existing drop inlet as the outside formwork for new concrete structure); and replaced the temporary Jersey barriers with architecturally appropriate precast concrete stormwater barriers. The sliplining pipe through the Museum area and under the Tavern was grouted in place for structural stability. Two new cleanout manholes were installed, one halfway along the pipe between two buildings and the other in front of the Tavern. The work was completed In April, in time to clear the site for the CrawDaddy Blues Fest in May.

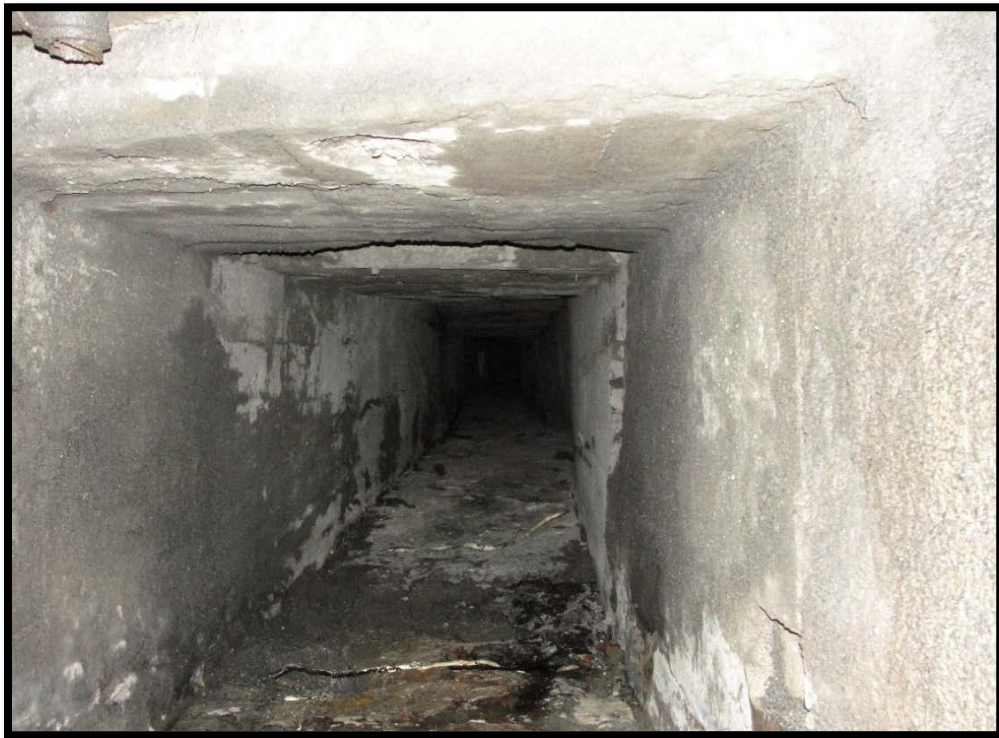
**Figure 24.** Box culvert after jet flushing, February 2015. Note exposed tree roots on floor.

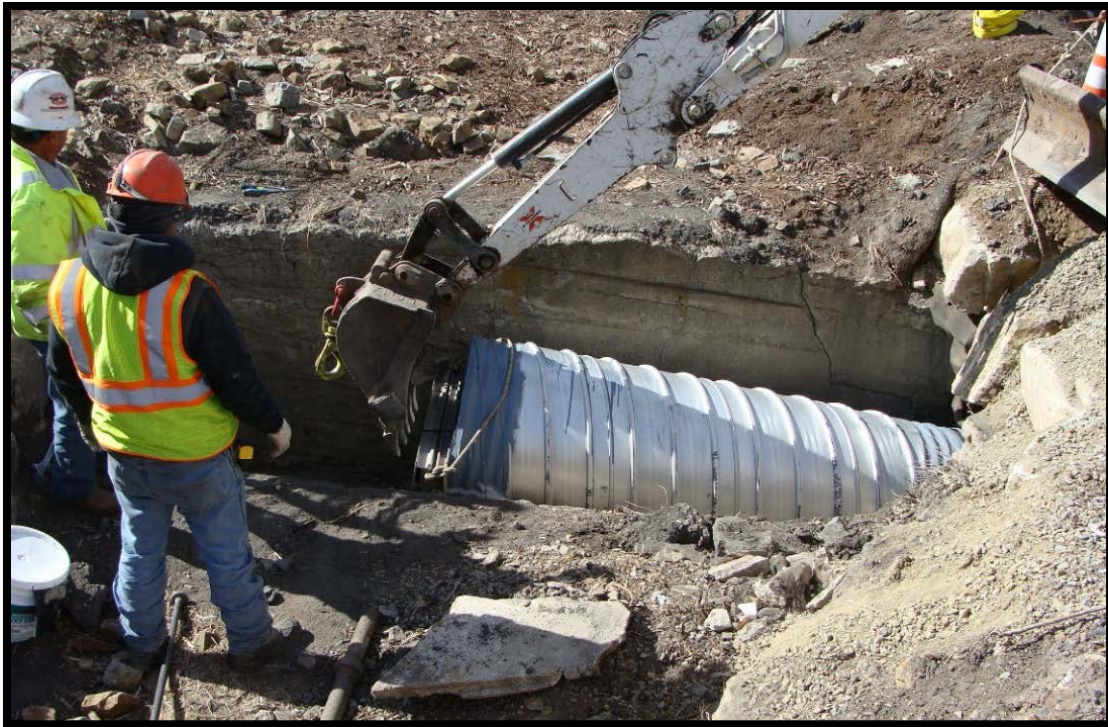
*Figure 25. Sliplining 36-inch diameter steel pipe into the box culvert at the upper drop inlet, February 2015*

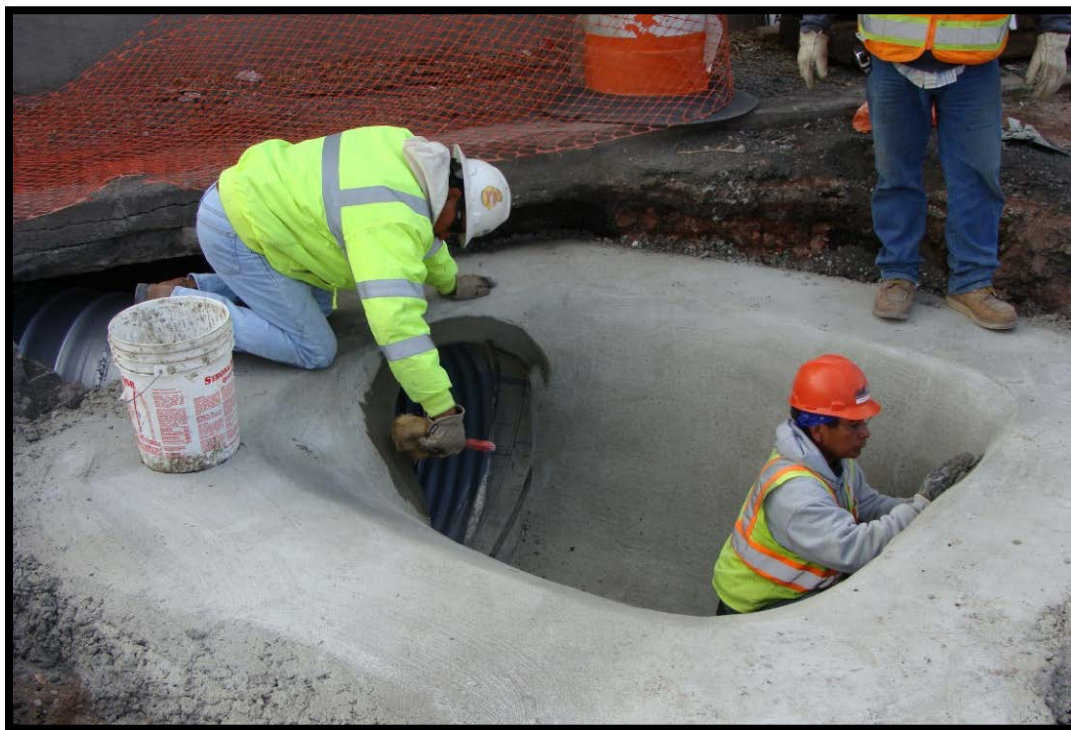
*Figure 26. Casting new clean-out manhole immediately outside of the Mine Shaft Tavern (later capped with concrete slab with manhole ring and cover), March 2015*

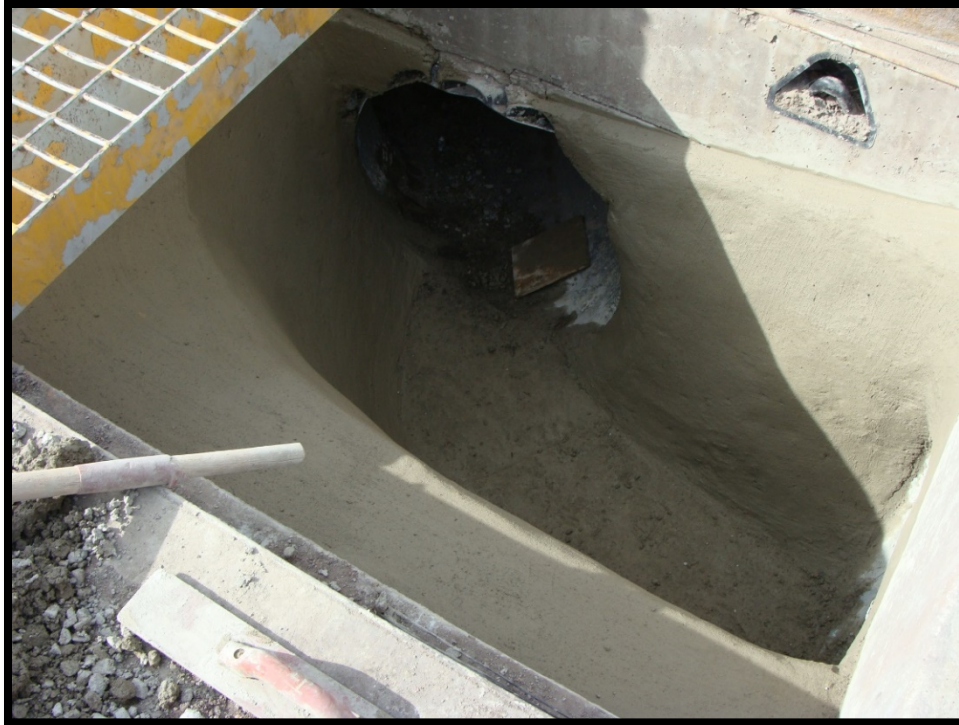
**Figure 27.** Newly cast grout infill to improve hydraulics in the lower NMDOT drop inlet in front of Mine Shaft Tavern, March 2015. Stormwater flows from right to left in this photo.

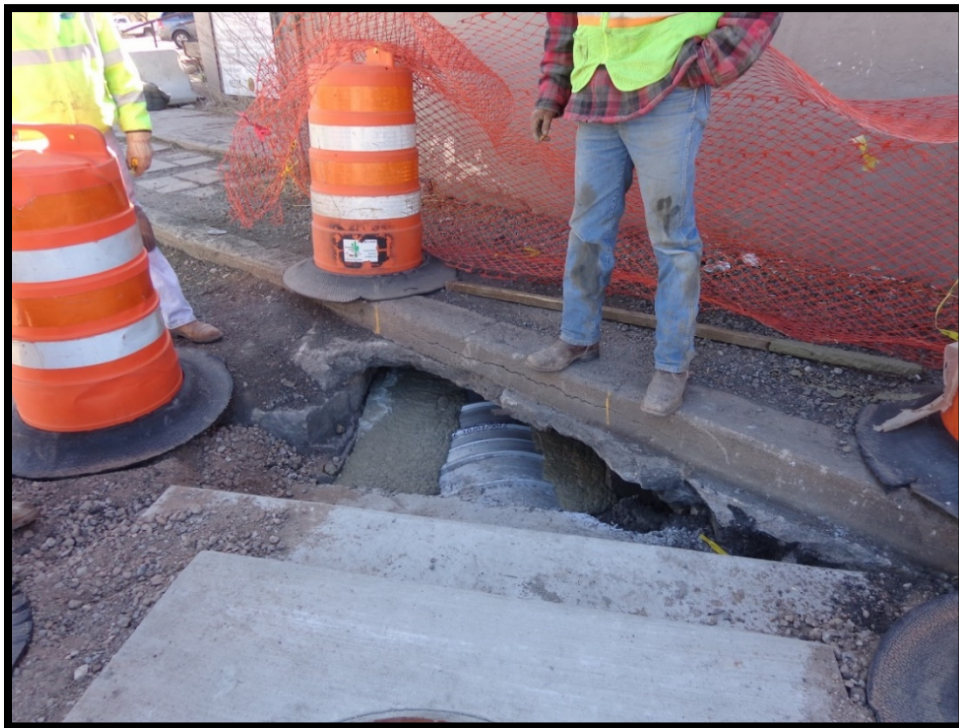
**Figure 28.** Grouting sliplined pipe into place, March 2015. Note fresh grout rising around the steel pipe and its location underneath the Mine Shaft Tavern.

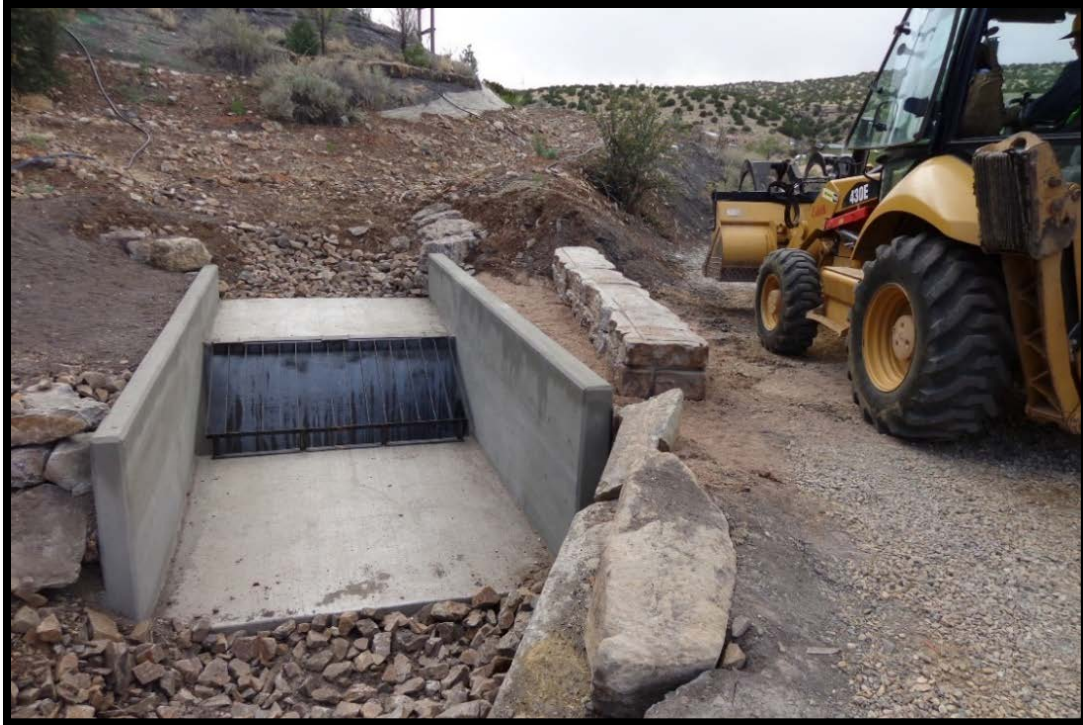
*Figure 29. Reconstructed upper drop inlet, April 2015. Note the mulched rock diversion ditch behind the drop inlet in upper left of photo.*

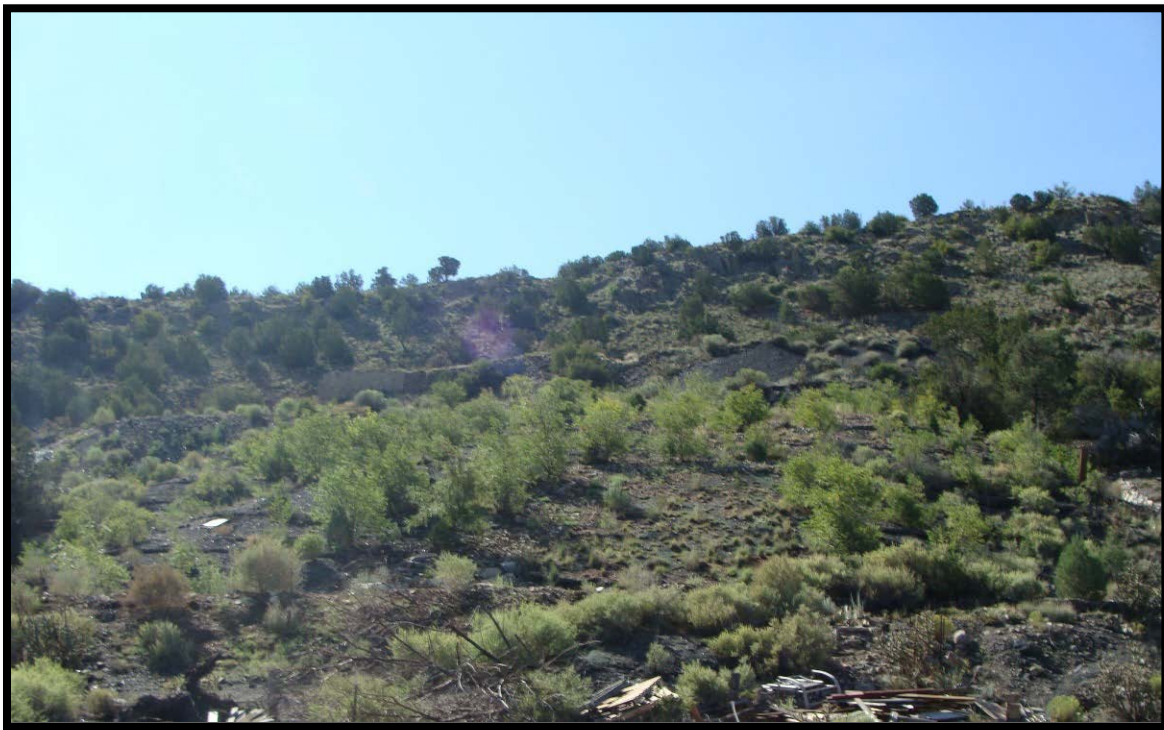
*Figure 30. View of the larger reclaimed gob pile in August 2016, which was initially reshaped and reclaimed in 1999 and additionally stabilized in 2014*
