## **SOCORRO WEST MINE SAFEGUARD PROJECT**

**Socorro, New Mexico**

Date Submitted: January 21, 1999

This Project successfully eliminated and safeguarded twenty four (24) abandoned underground mine shafts, adits, and stope openings while preserving highly significant bat habitat in the mine workings. Construction was begun on March 14, 1996 and completed by July 11, 1996 at a final construction cost of \$109,163.54.

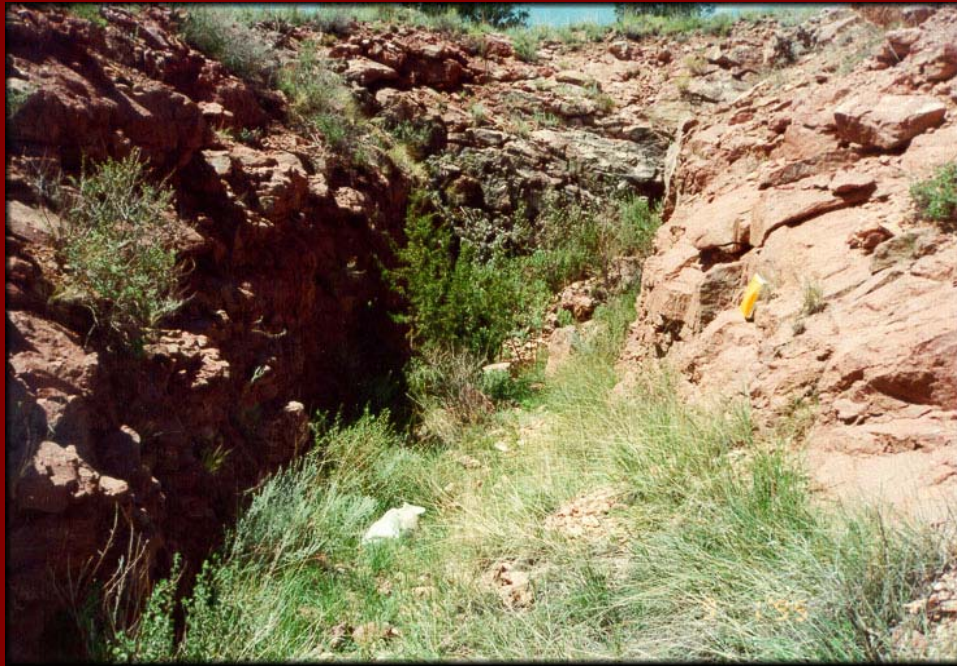
Entry trench to the  
Feature 5 Adit,  
preconstruction;  
note that the trench  
angles to the right to  
the adit entry

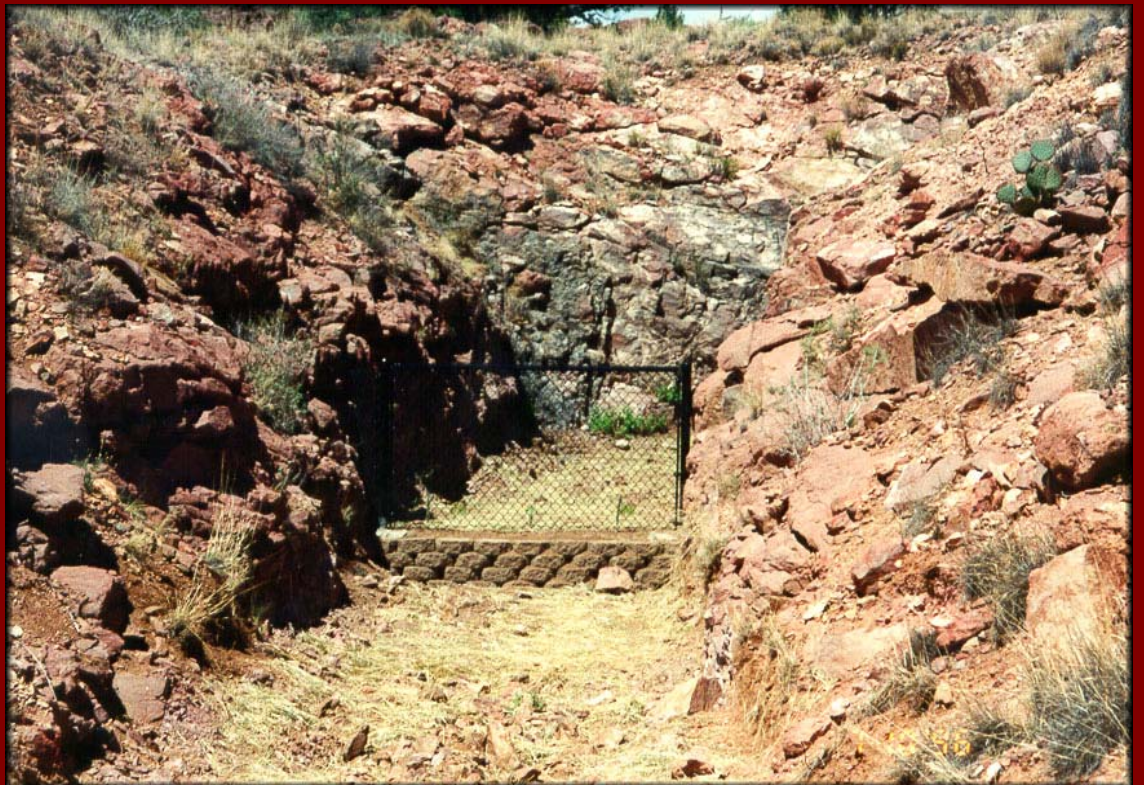
Entry  
trench to  
the  
Feature 5  
Adit with  
chain link  
fence,  
completed

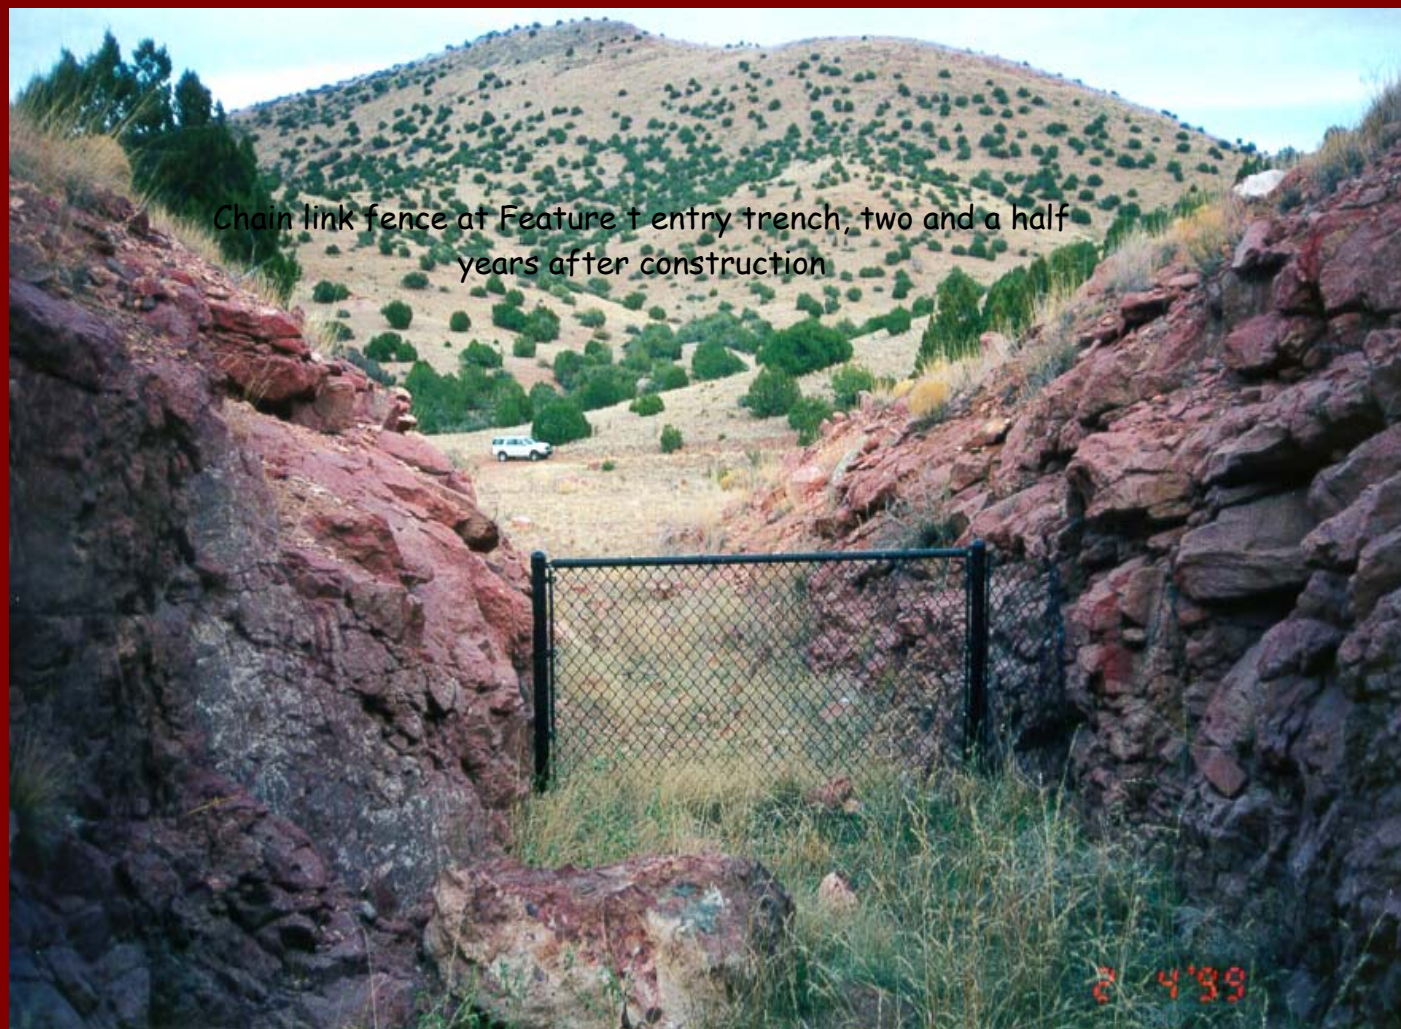
Chain link fence at Feature 1 entry trench, two and a half years after construction

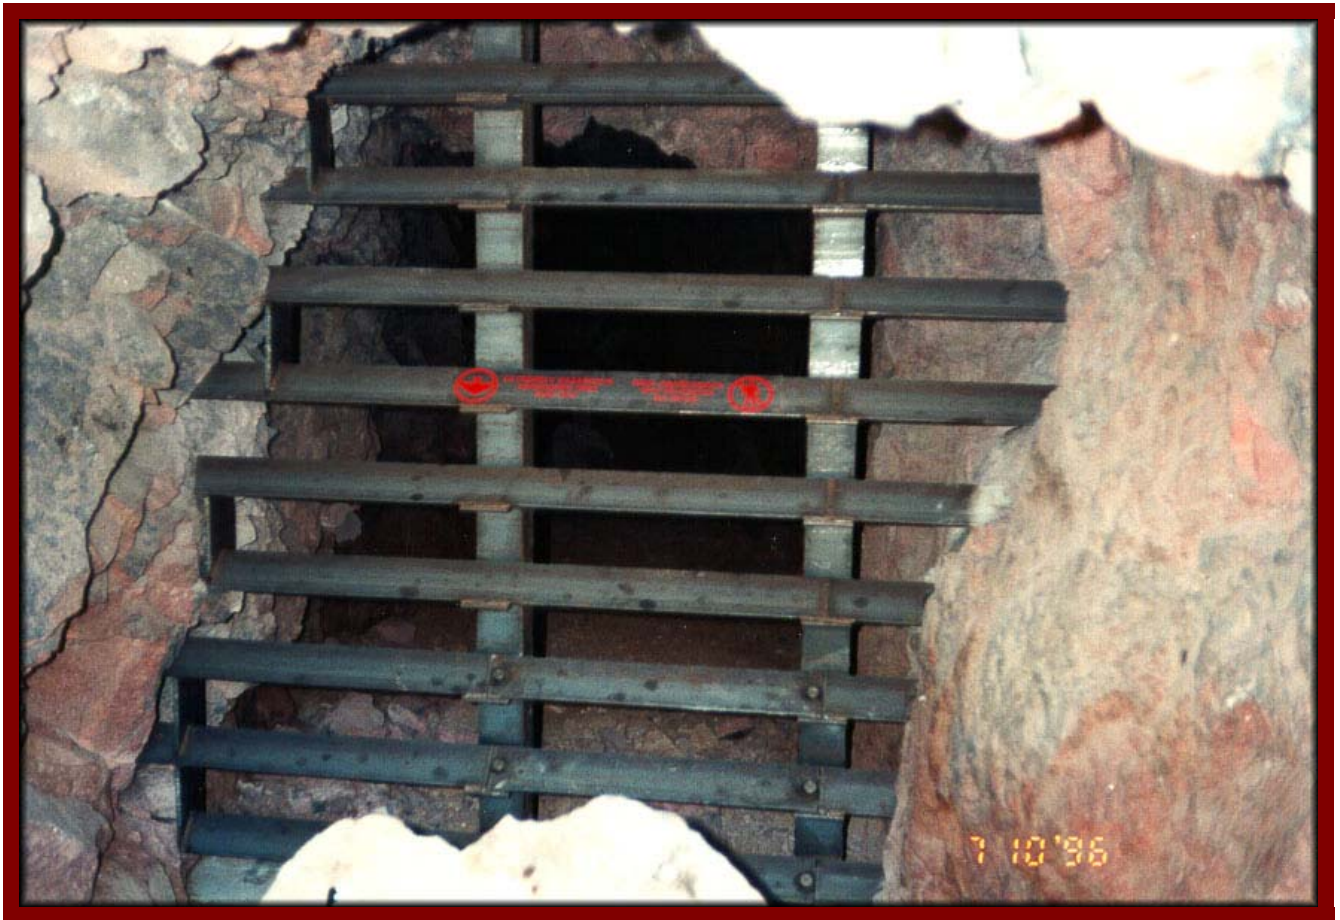
**Completed bat closure in the Feature 5 Adit**

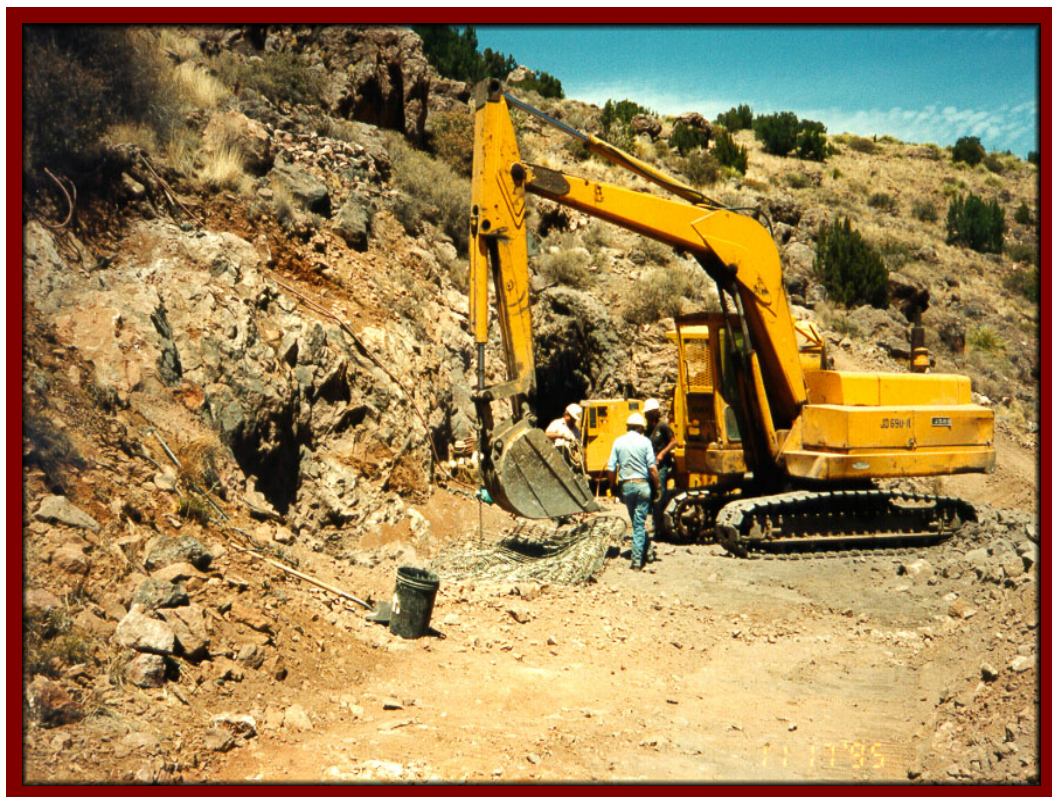
Cable net at  
Feature 6A Shaft  
under construction

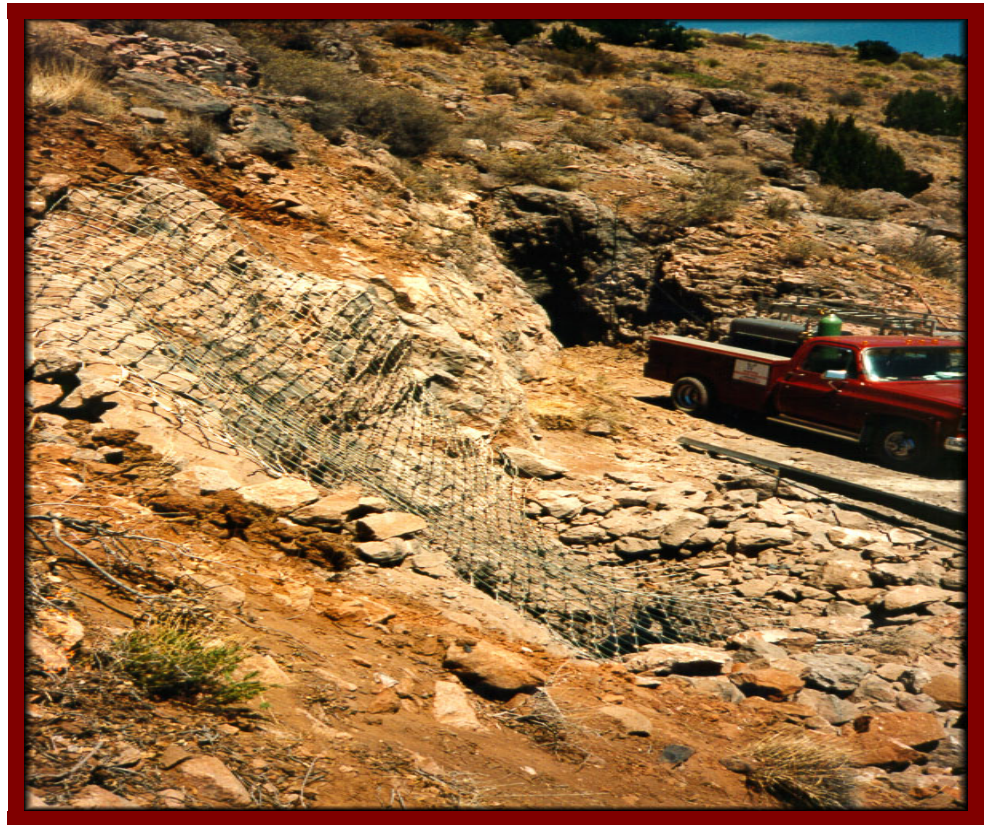
Completed cable net at  
Feature 6A Shaft

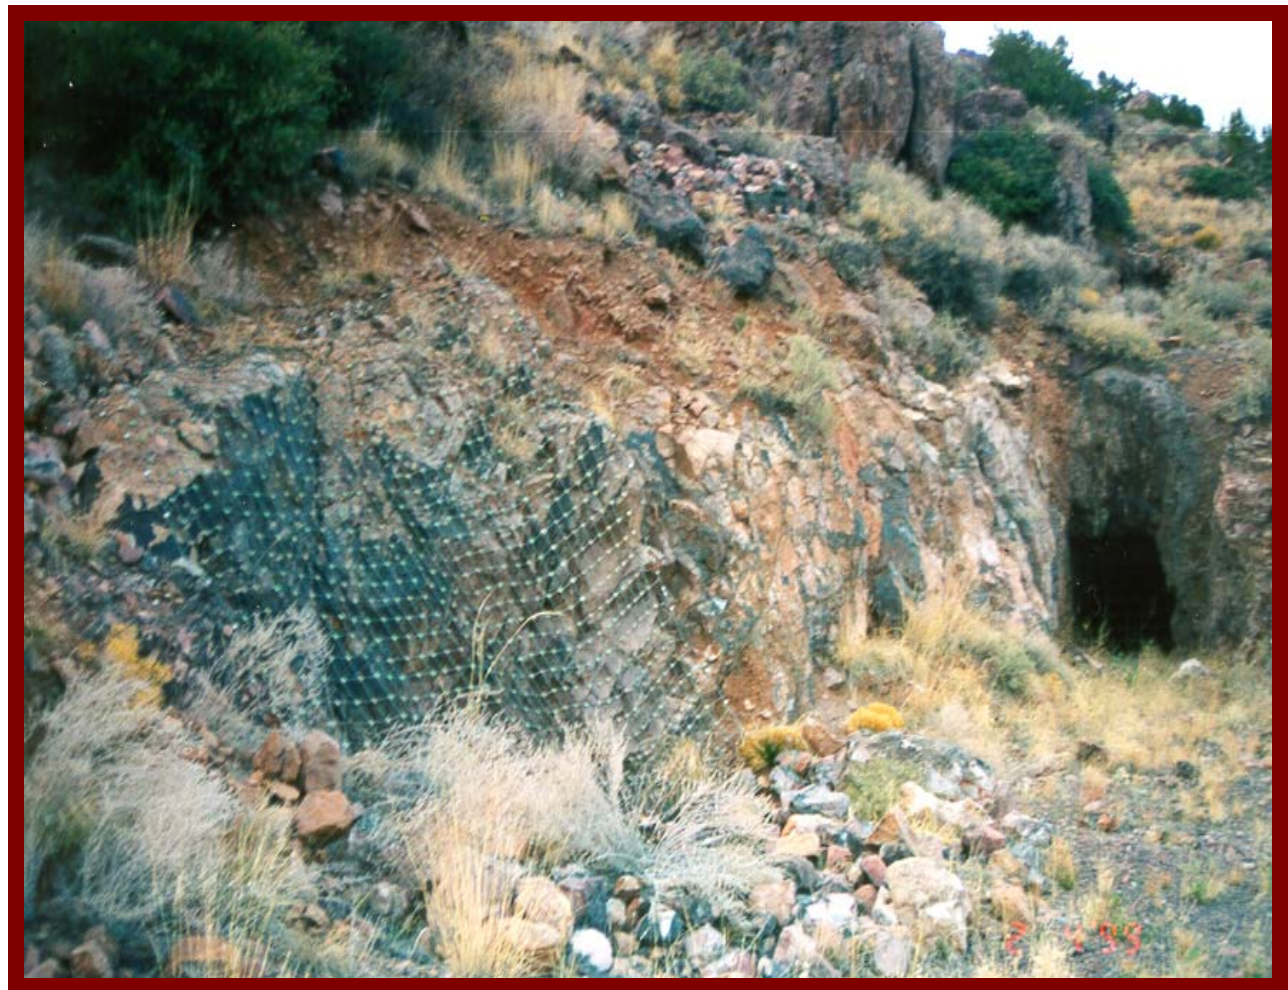
Completed cable net at  
Feature 6A Shaft

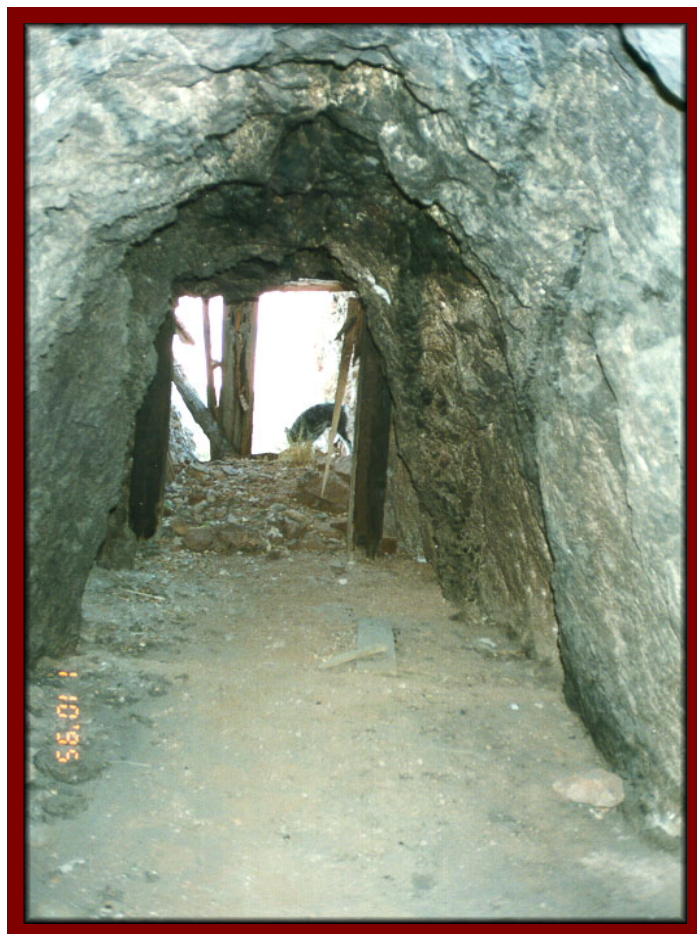
Feature 7 Adit,  
preconstruction

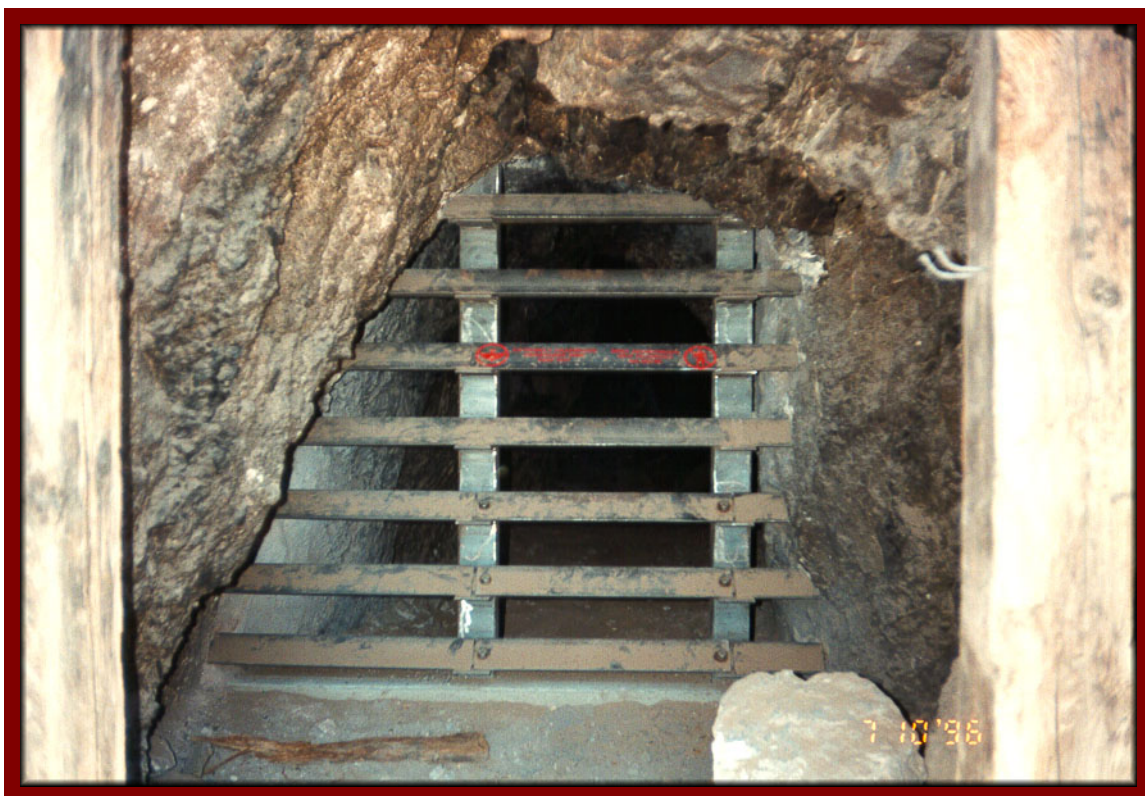
Completed  
bat closure  
in the  
Feature 7  
Adit

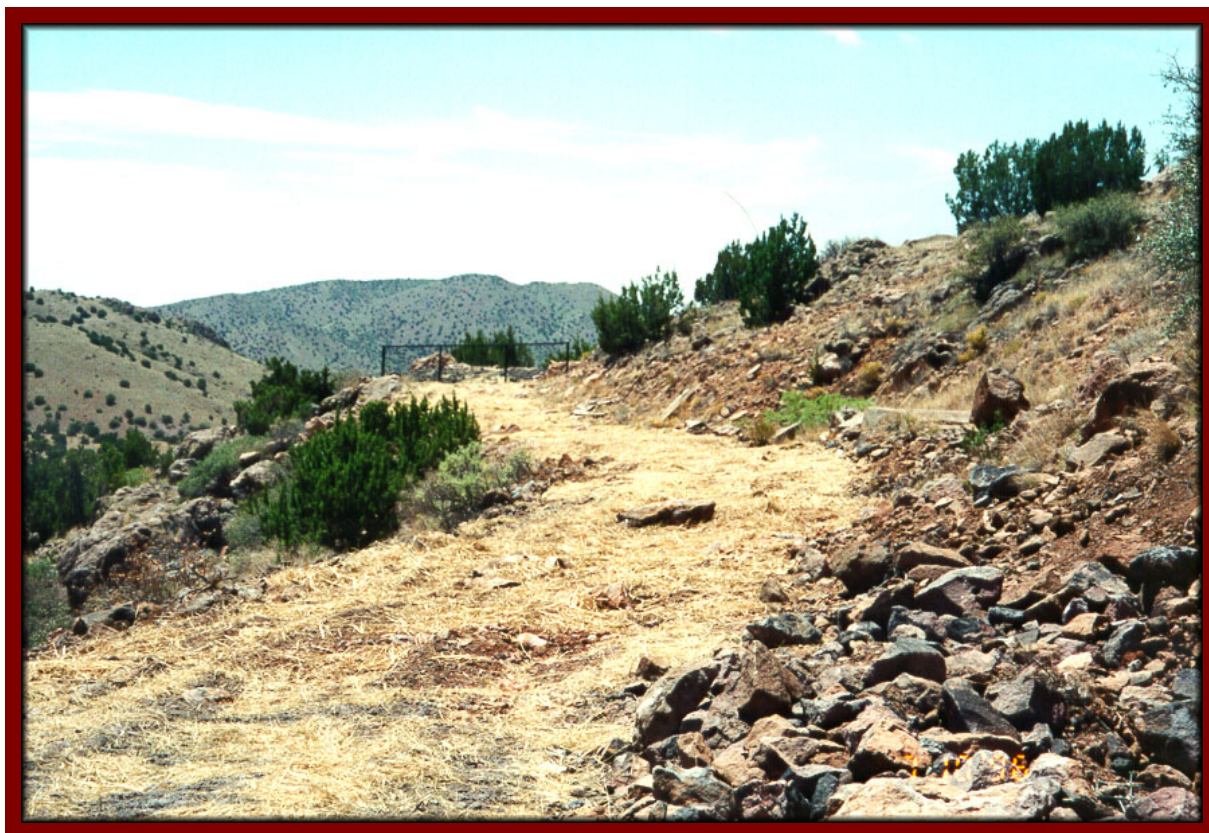
Chain link fence across access road to Features 6A, 6 and 7

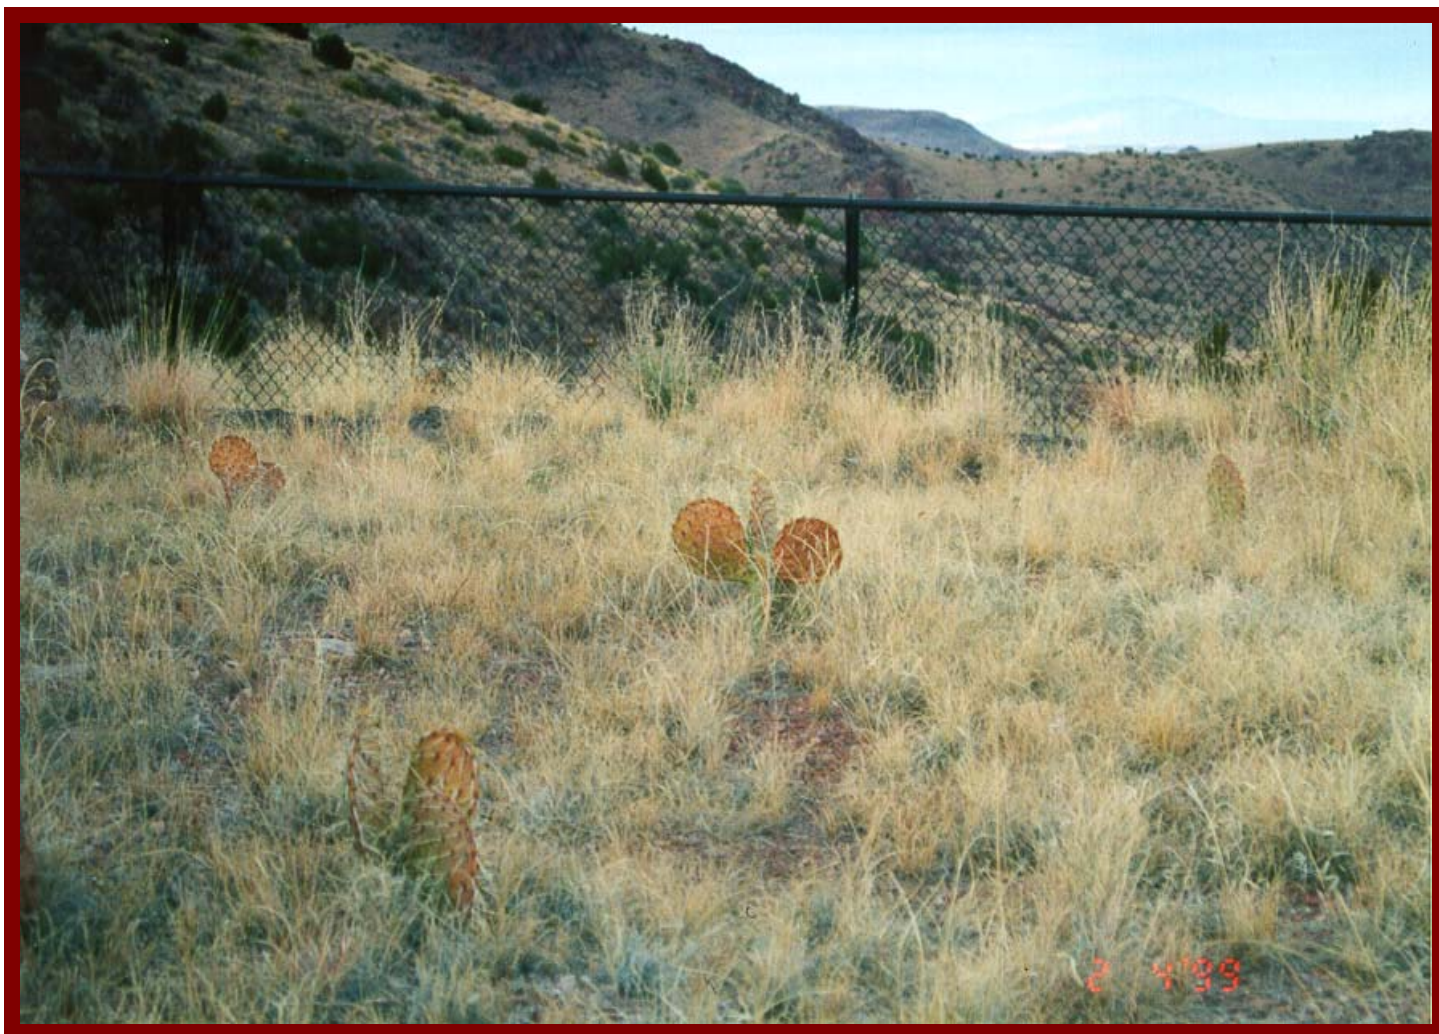
Bramble barrier of cactus by chain link two and a half years after construction

Because of the high level of vandalism experienced at the site and the high value of the natural resource being protected, the Bureau took special care in its designs to make vandalism more difficult. The bat closures were designed using heavy steel members. Columns were filled with concrete and crossbars reinforced against cutting with internal stiffeners. Access roads to the openings were closed by ripping, constructing earth berms and PVC-coated chain link fencing, and placing large boulders across the access roads. At one location, a bramble barrier consisting of live cactus cuttings was placed at the chain link fence. Cuttings have successfully rooted and are growing to a size to act as a barrier.

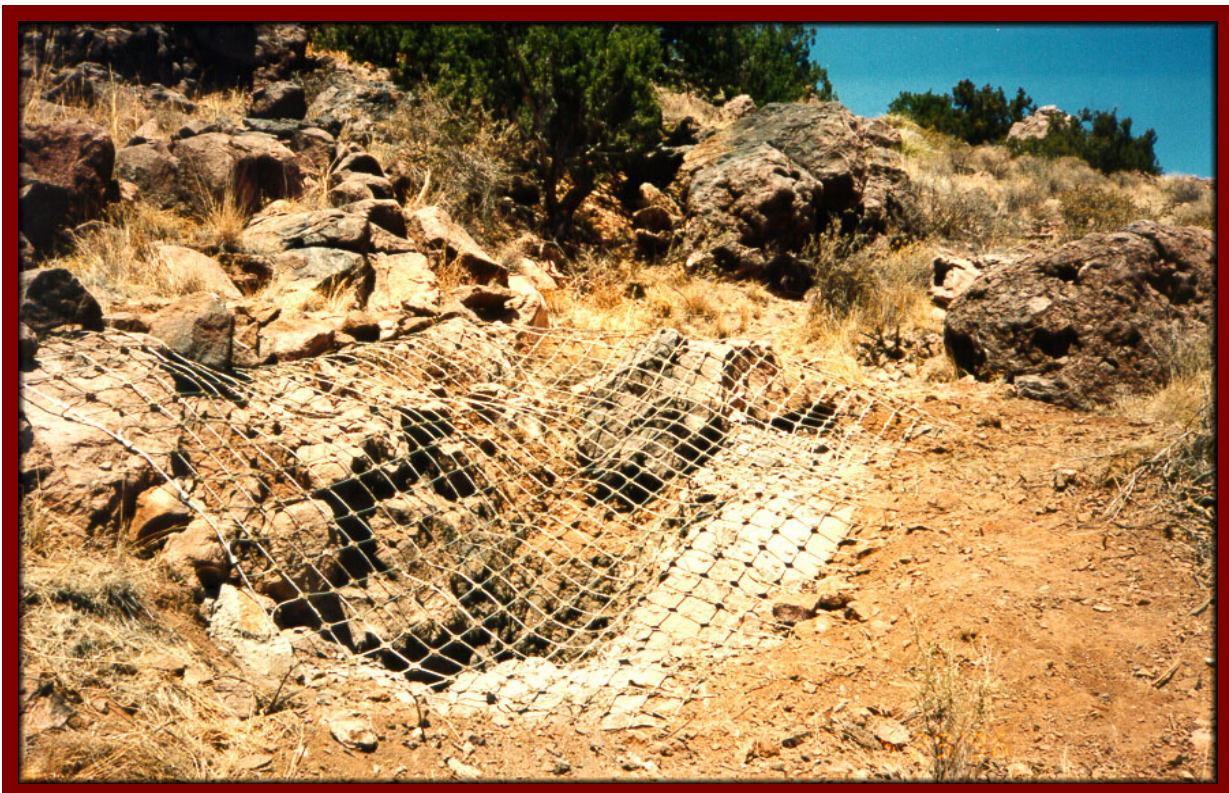
Feature 8 Open  
Stope,  
preconstruction  
(note overhanging  
boulder in upper  
left)

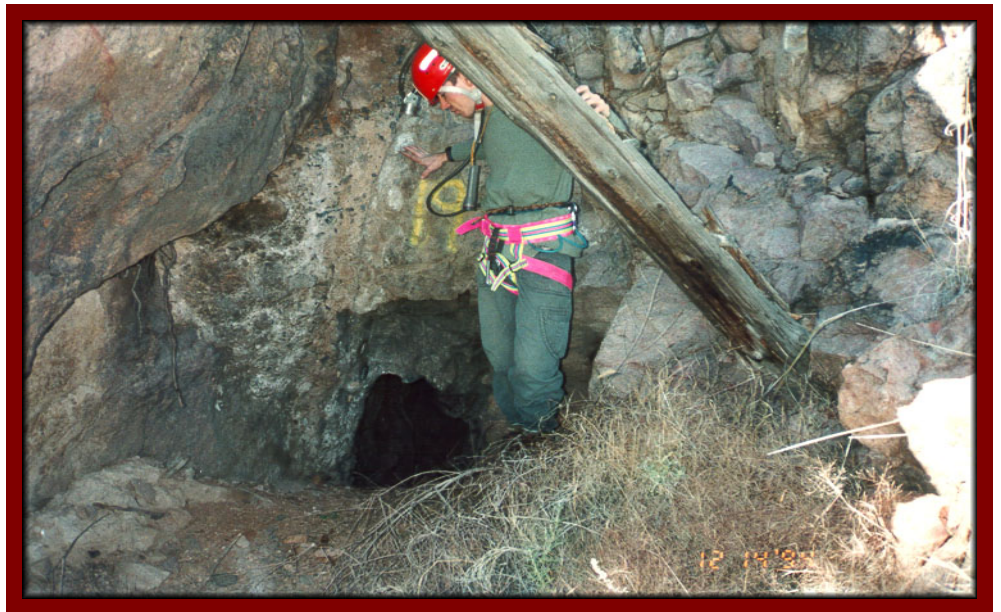
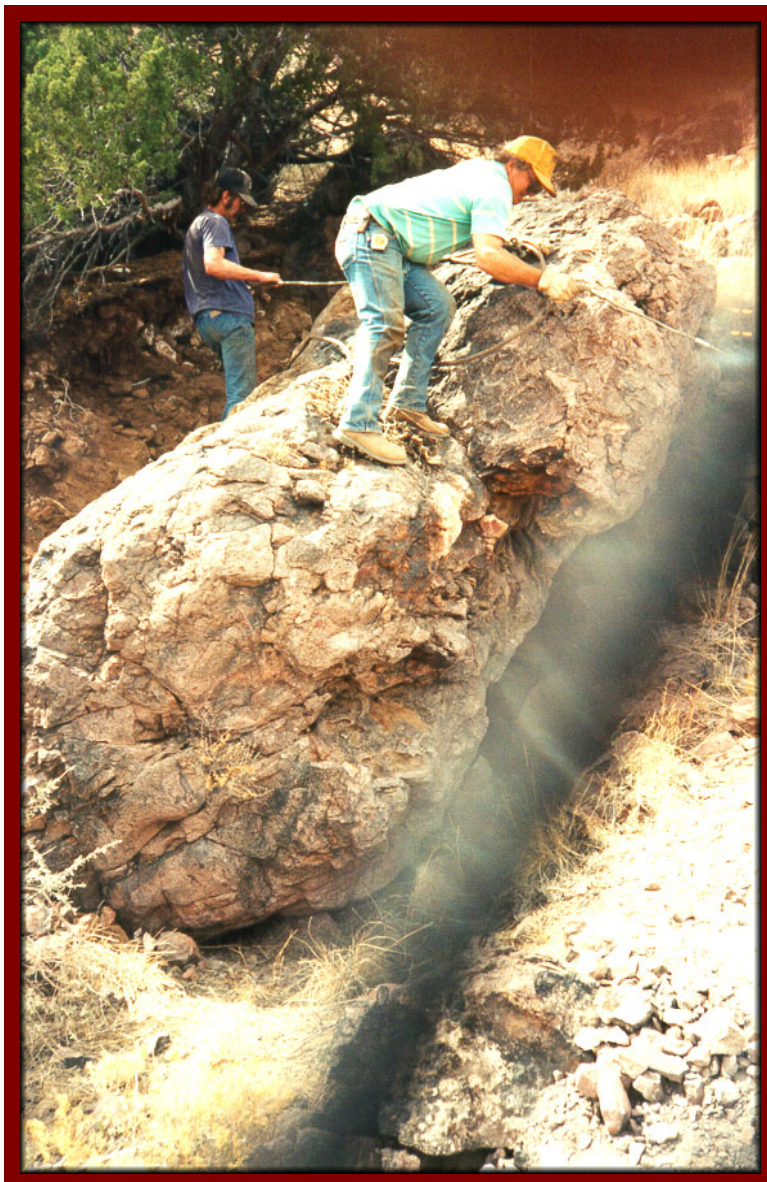
Moving the  
overhanging boulder  
with cable and a  
come-along to block  
the opening at the  
Feature 8 Open  
Stope

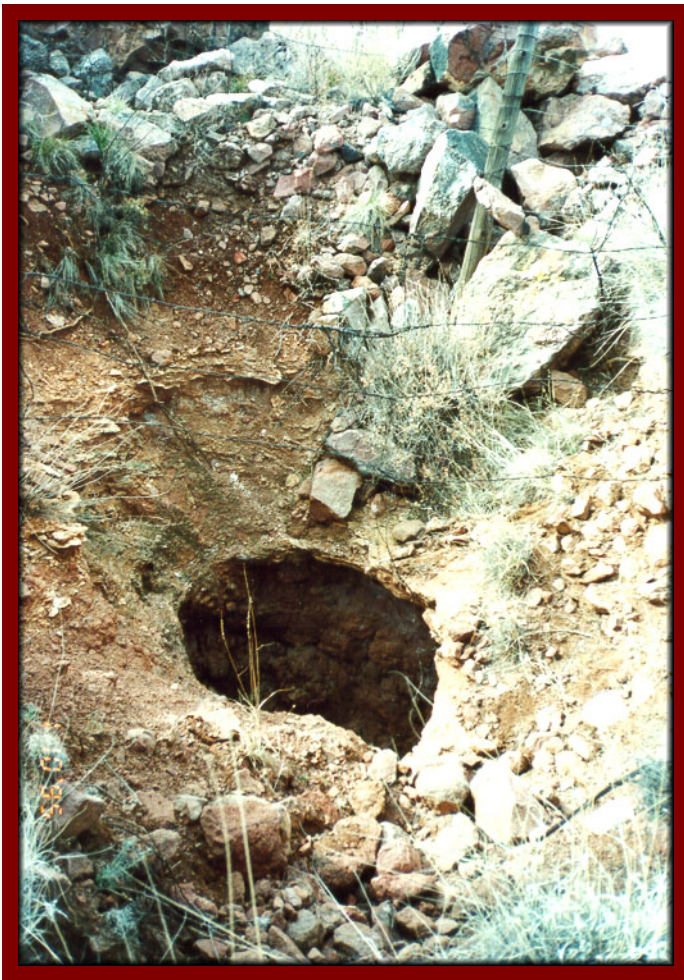
Feature 9 Stope Opening,  
preconstruction

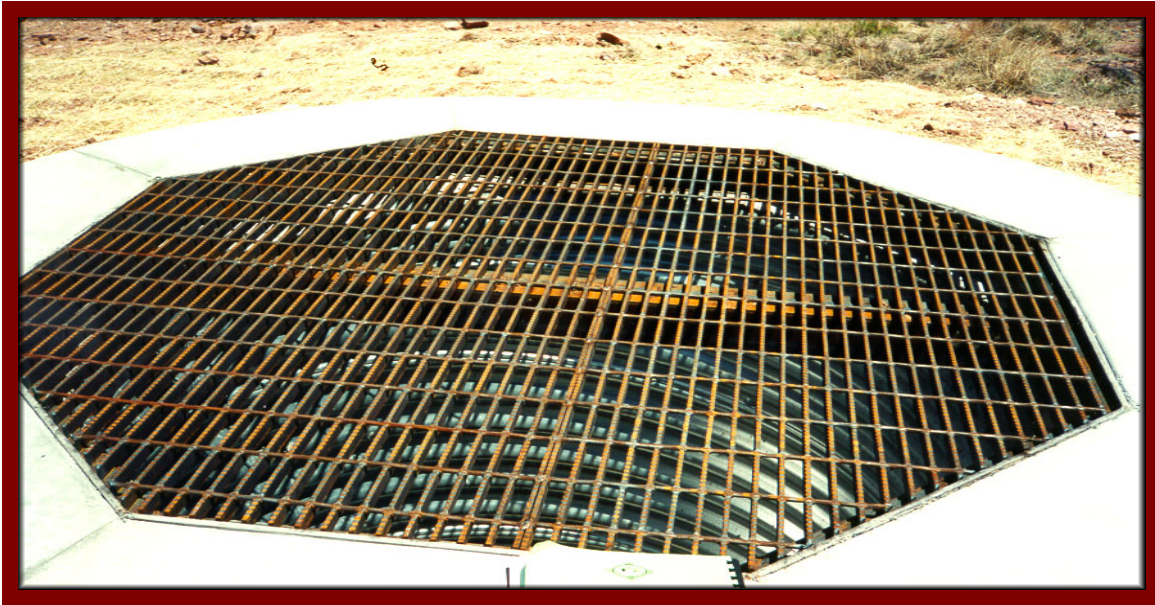
Close-up of the grated closure at the Feature 11 Shaft, showing the corrugated steel pipe riser (inside a polyurethane foam plug and masonry collar)

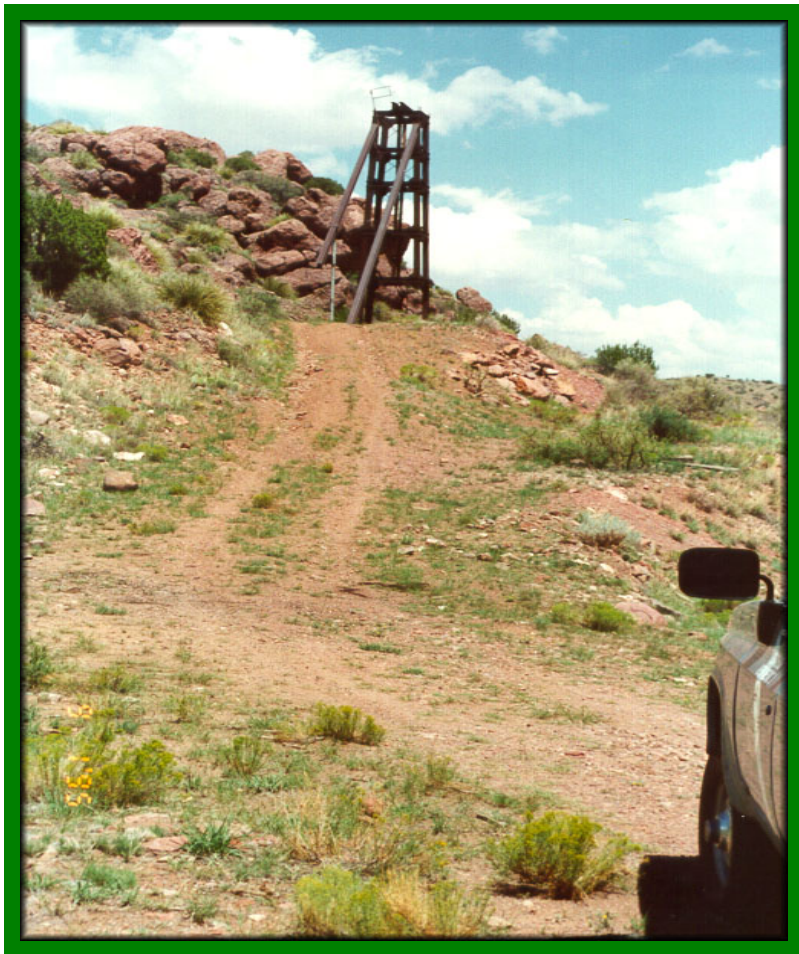
Headframe at the Feature 4  
Shaft, preconstruction

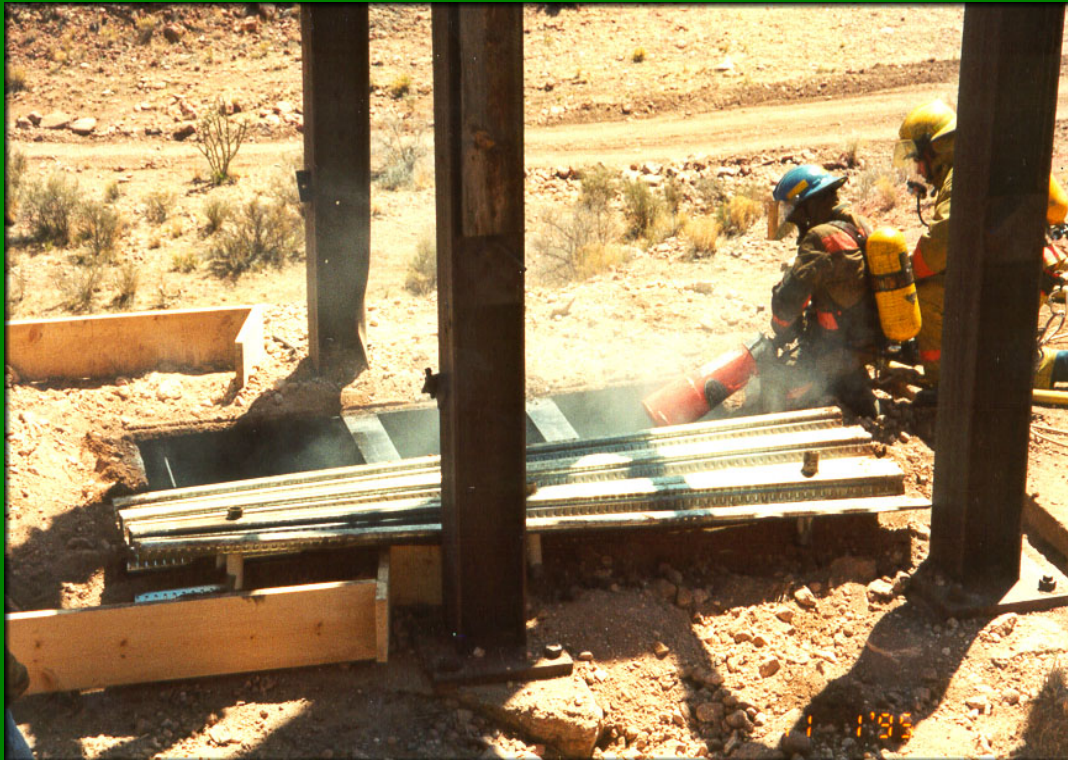
Firefighters attempting to put out fire in the Feature 4 Shaft during construction

During construction while welding the forms for the Feature 4 concrete cap, collapsed timbers in the shaft accidentally caught on fire. Fire fighters from the New Mexico Fire Training Academy in Socorro unsuccessfully tried to extinguish the smoldering timbers. The timbers continued to smolder for another six or more months, but fortunately did not seem to affect the bats.

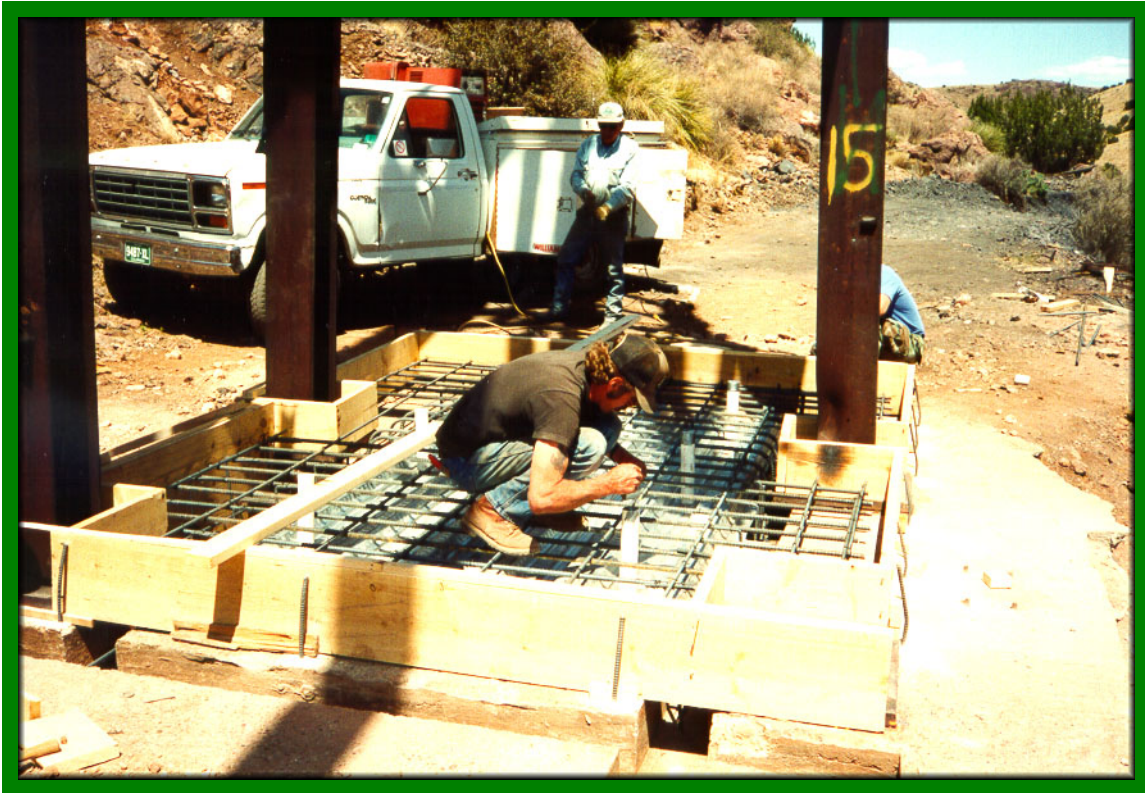
Constructed  
form for  
reinforced  
concrete slab  
at the Feature  
4 Shaft

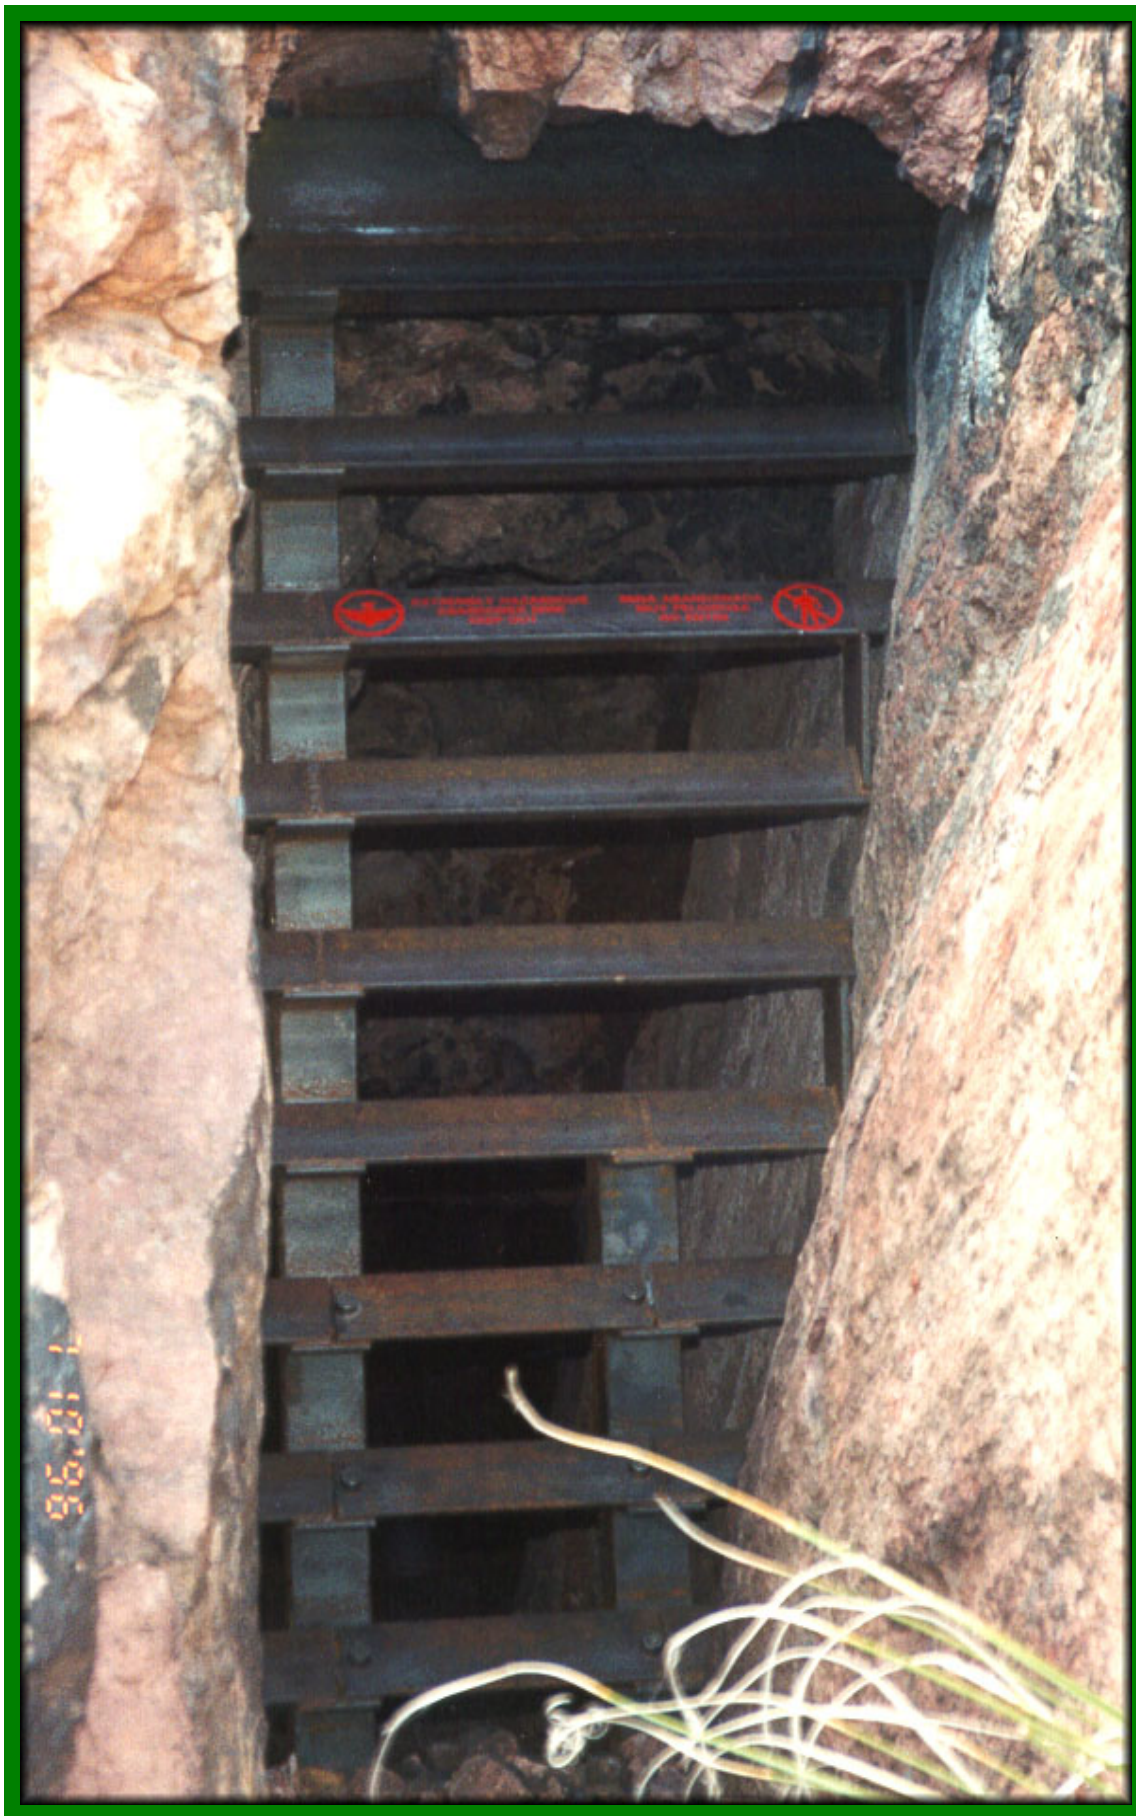
Completed  
bat closure  
at the  
Feature 4A  
Adit  
(top  
removable  
crossbar  
was  
vandalized  
and replaced  
in 1998)

To date all closures, but one, have been successful in safeguarding the dangerous mine openings. Using a torch, vandals cut a removable crossbar at the steel bat closure at Feature 4A, the most accessible of the bat closures. The AML Bureau arranged to shop-fabricate a replacement bar shortly after they detected the breach. No significant settlement of fills has occurred. Concrete and polyurethane foam structures remain intact. The weathering steel on the exposed bat closures and grated closures has rusted to a soft brown color that blends into the landscape. People who visit the site can do so without fear of their children falling into a mine void. The land and mineral owners have a much-reduced potential liability for injury or death on their properties. Although not a major objective of the project, native grass and shrub revegetation of the areas disturbed by construction has been highly successful.

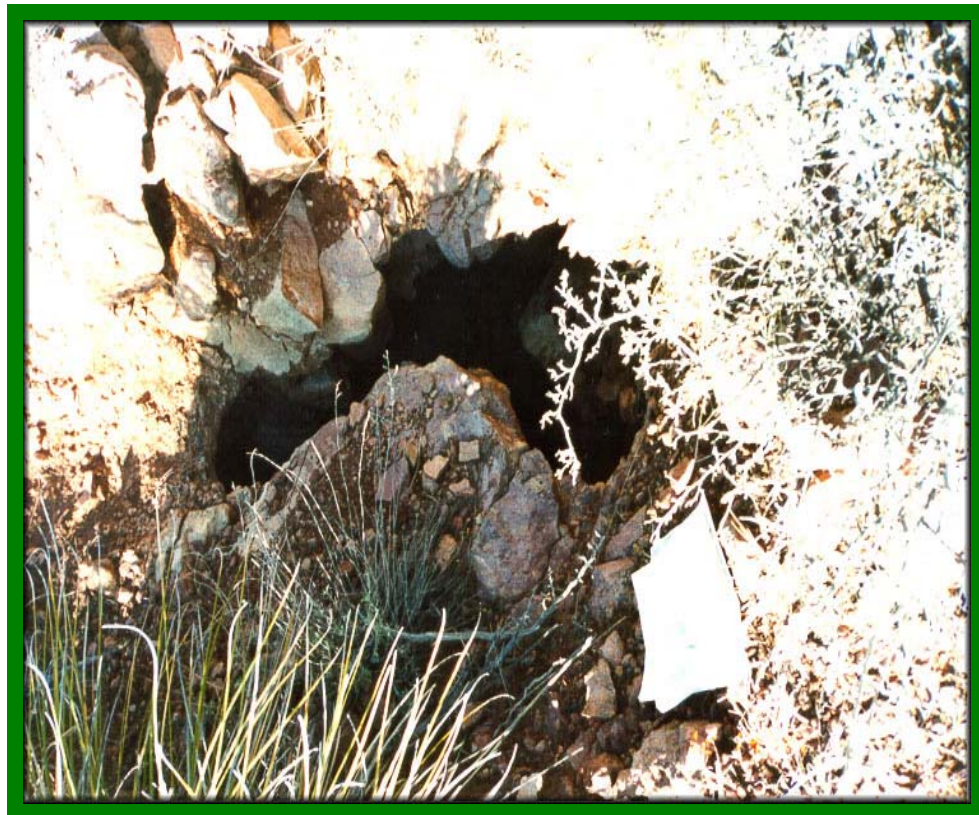
Feature 19 Adit backfilled with rock

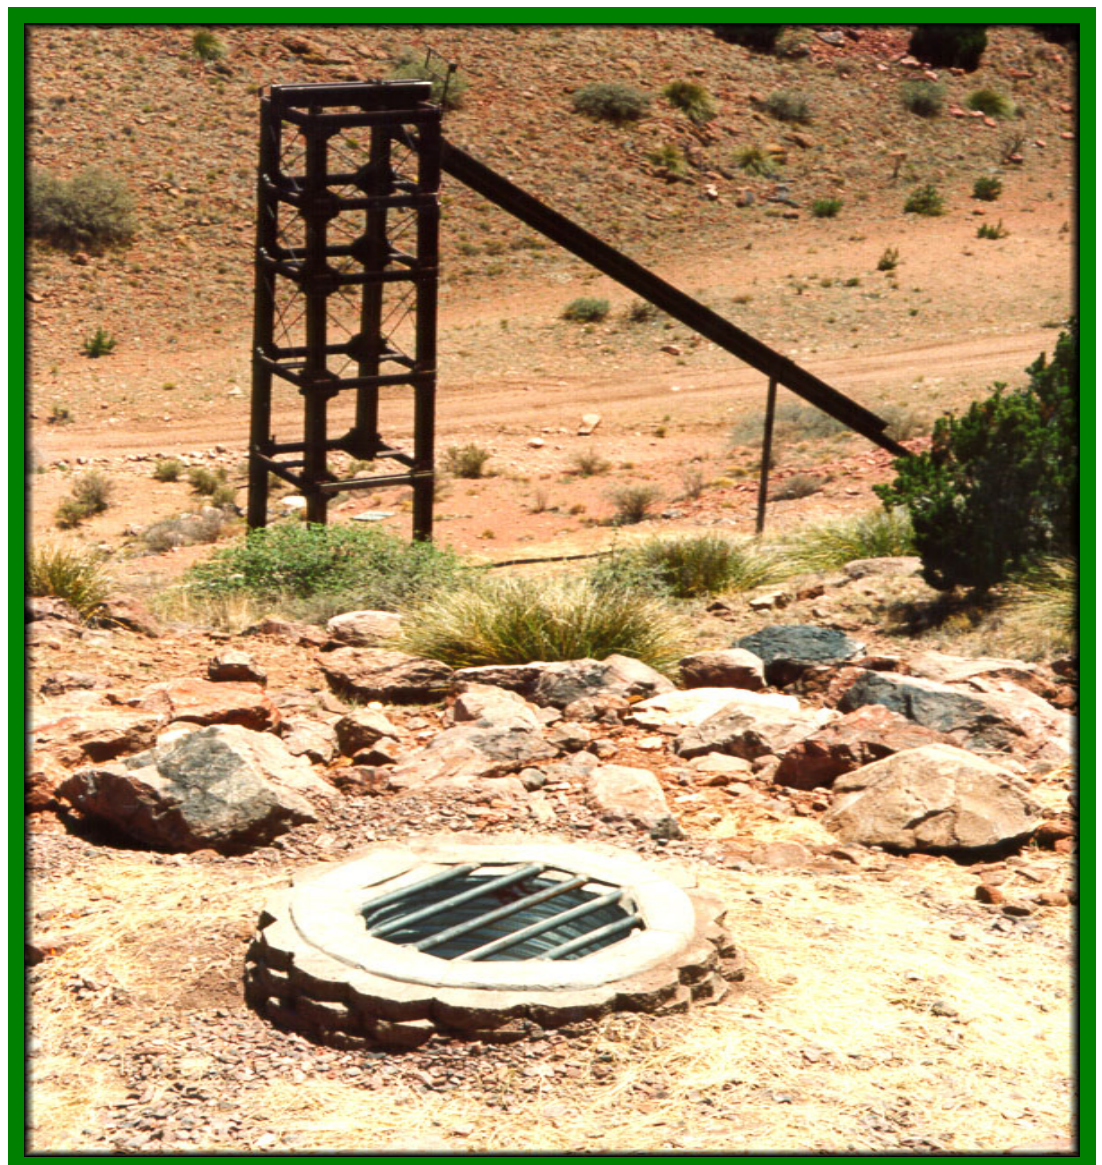
Completed bat  
closure with  
corrugated  
steel pipe riser  
in  
polyurethane  
foam plug (this  
feature was  
later  
vandalized)
