## **SOCORRO WEST MINE SAFEGUARD PROJECT**

**Socorro, New Mexico**

Date Submitted: January 21, 1999

This Project successfully eliminated and safeguarded twenty four (24) abandoned underground mine shafts, adits, and stope openings while preserving highly significant bat habitat in the mine workings. Construction was begun on March 14, 1996 and completed by July 11, 1996 at a final construction cost of \$109,163.54.

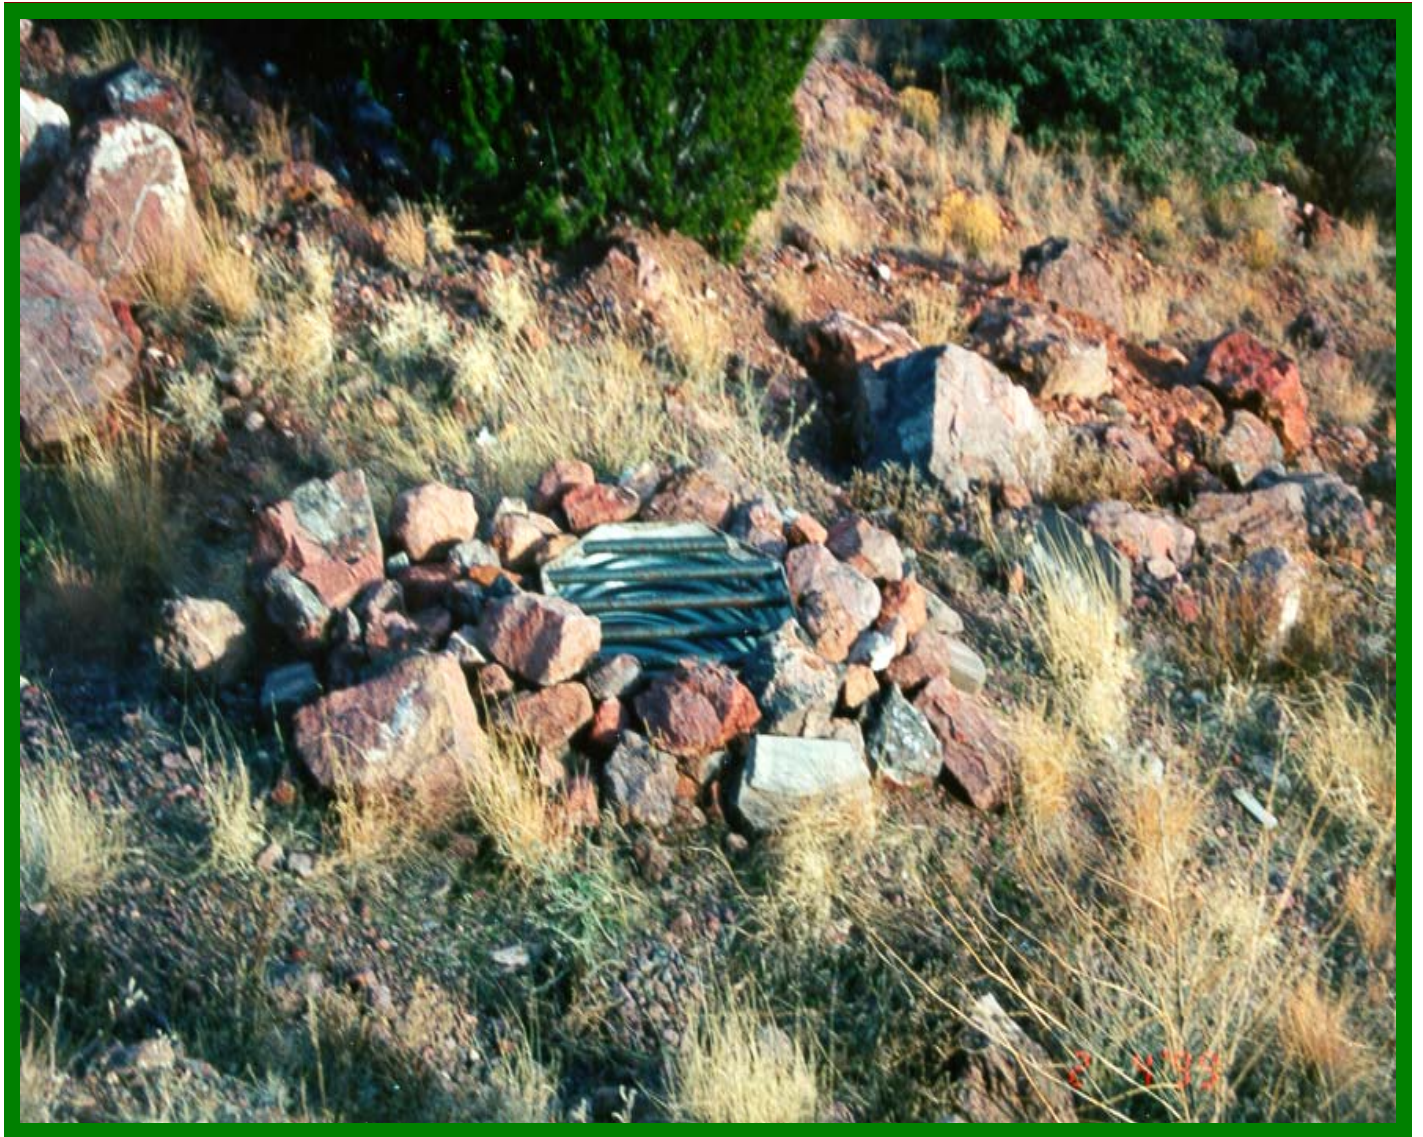
Feature 18 bat closure following vandalism, mortarless concrete units replaced with native rock

The closure methods have weathered attempts at vandalism well. During inspections, AML staff often finds rocks thrown or rolled on the cable net at Feature 17. A few have been too large to remove by hand and remain on the net, but the net remains intact. The masonry wall at the polyurethane foam plug with corrugated steel pipe riser at Feature 18 was torn apart and the pieces thrown into the closure, blocking the opening in the rock. AML staff has since placed rock around the riser piper and no further vandalism has occurred. Fortunately this opening was not an important bat entrance nor was it important for ventilation.

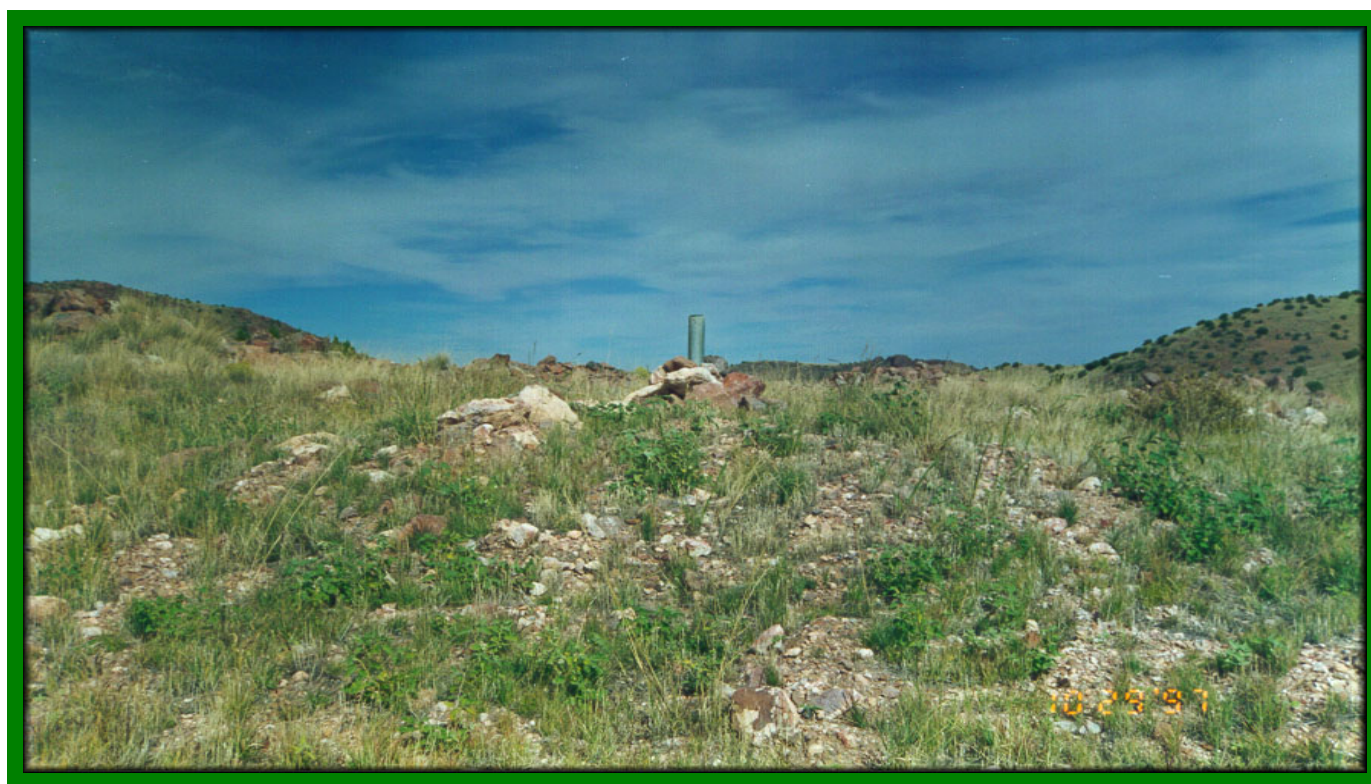
Survey marker at the backfilled concrete cap at the  
Feature 18A Vent Shaft, one year after construction

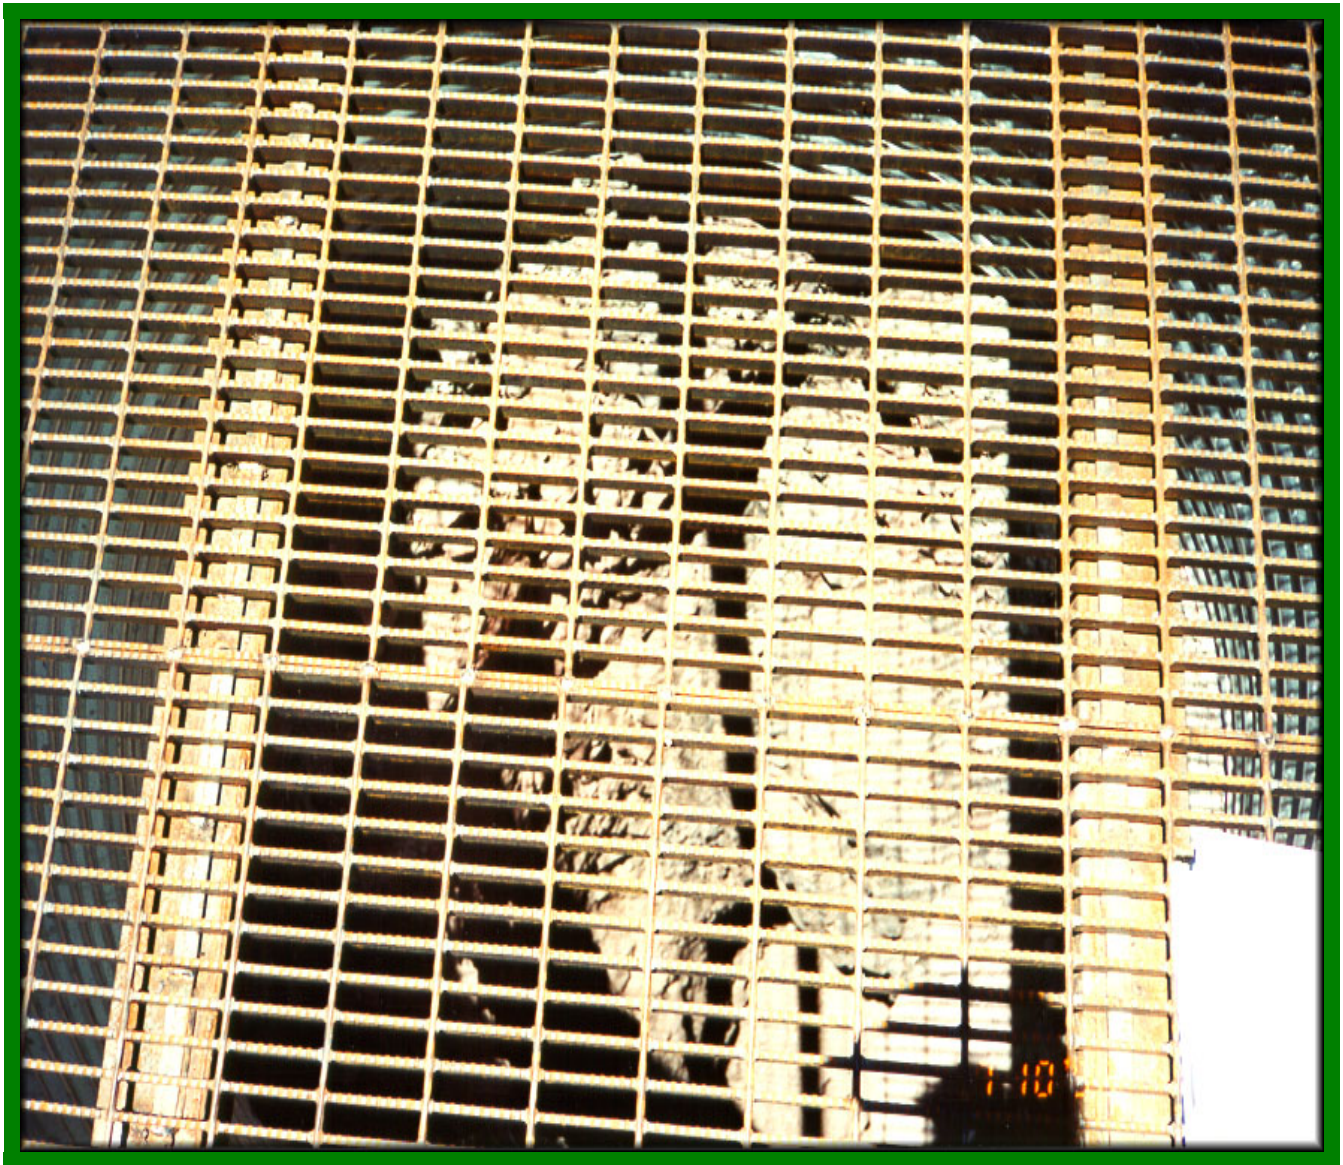
Completed grated closure at the Feature 12 Open Stope; note the corrugated steel pipe riser on rock around the stope opening

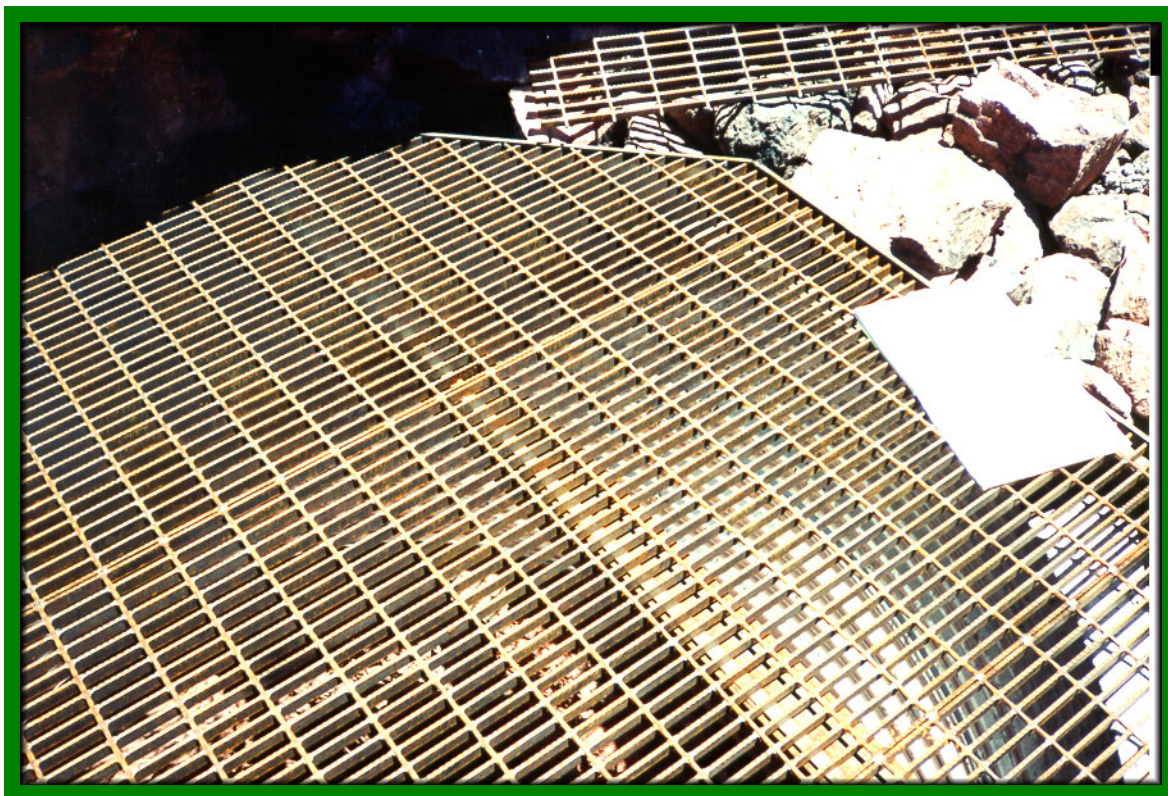
Completed grated closure with corrugated steel pipe riser at the Feature 13 Open Stope

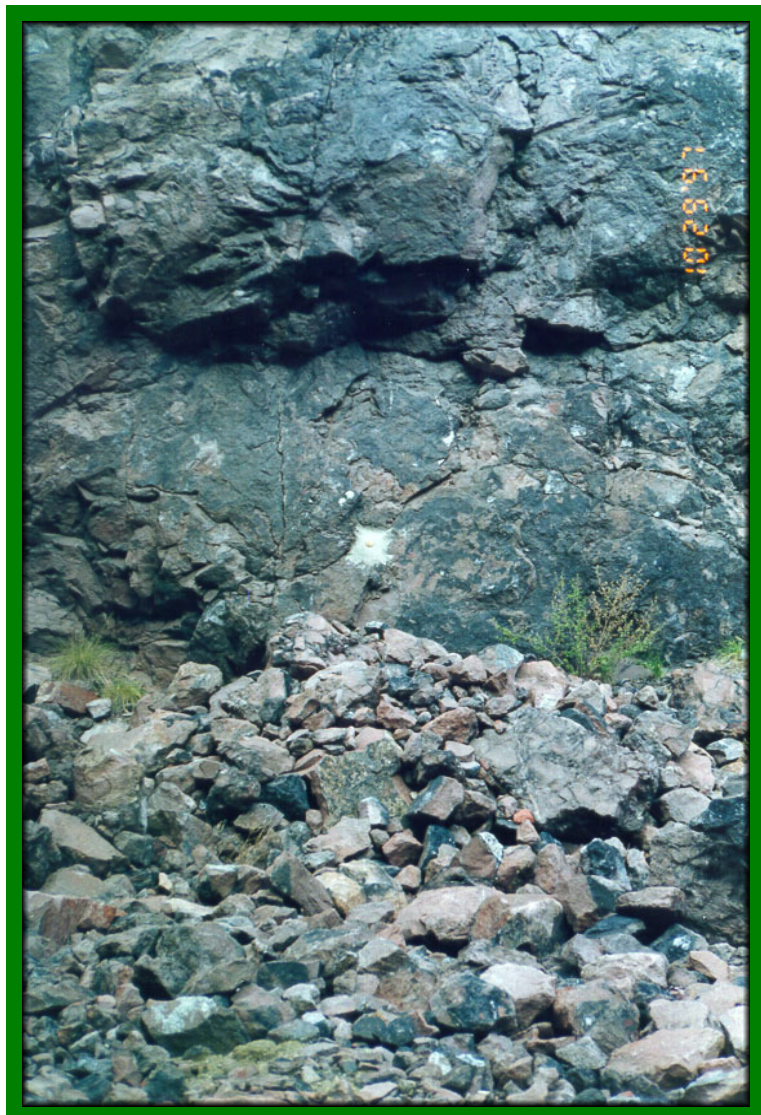
Backfilled Feature 14 Open  
Stope; note survey cap  
grouted into rock face

At the pre-bid conference, we discovered that vandals had partially filled the Feature 14-stope opening with rock. The Bureau issued an addendum to backfill the remaining opening with rock, rather than to construct the designed polyurethane foam plug. Other minor vandalism occurred during construction, including removal of survey markers from wet concrete and exploding a small piece of concrete out of the concrete cap at Feature 4.

When Triple L Constructors mucked open the Feature 14-stope opening, the original design calling for a polyurethane foam plug closure clearly could not be built. They discovered a previously unknown drift just below the opening in the bedrock surface. The opening however was well suited for a cast-in-place concrete shaft closure, which was constructed on competent bedrock and covered with about five feet of soil.

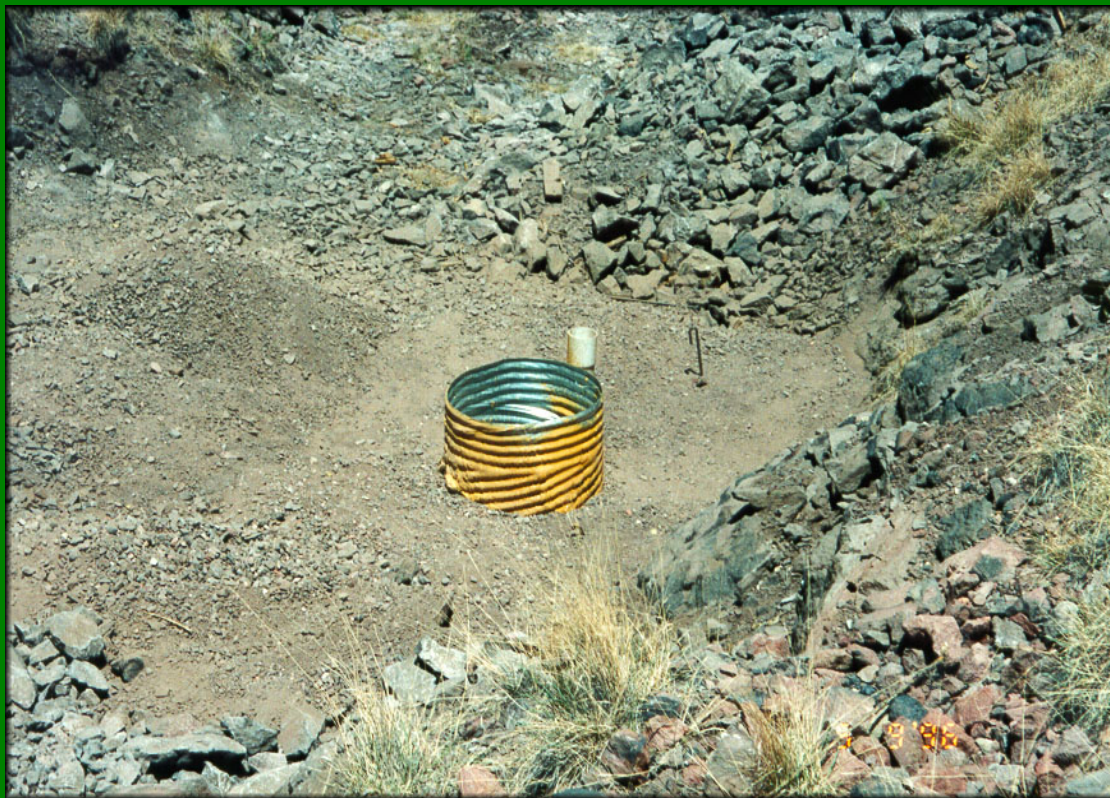
Corrugated  
steel pipe  
riser and  
polyurethane  
foam plug in  
place at the  
Feature 15  
Shaft

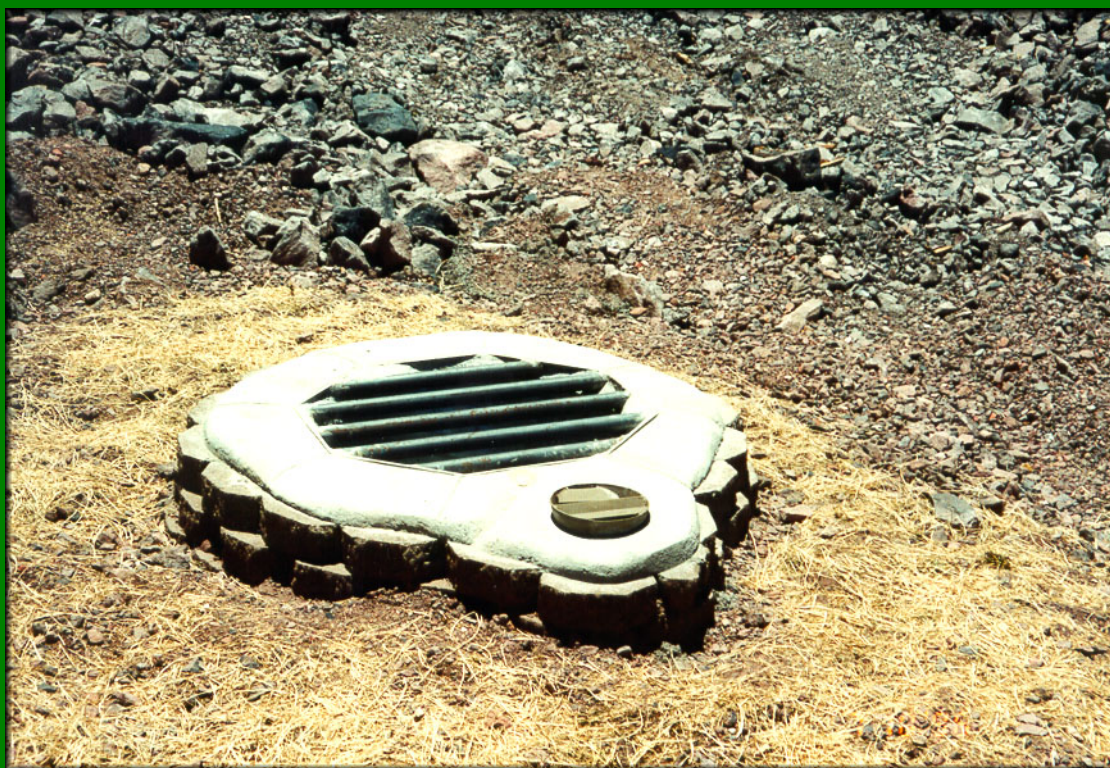
Completed  
bat closure  
with  
corrugated  
steel pipe  
riser at the  
Feature 15  
Shaft

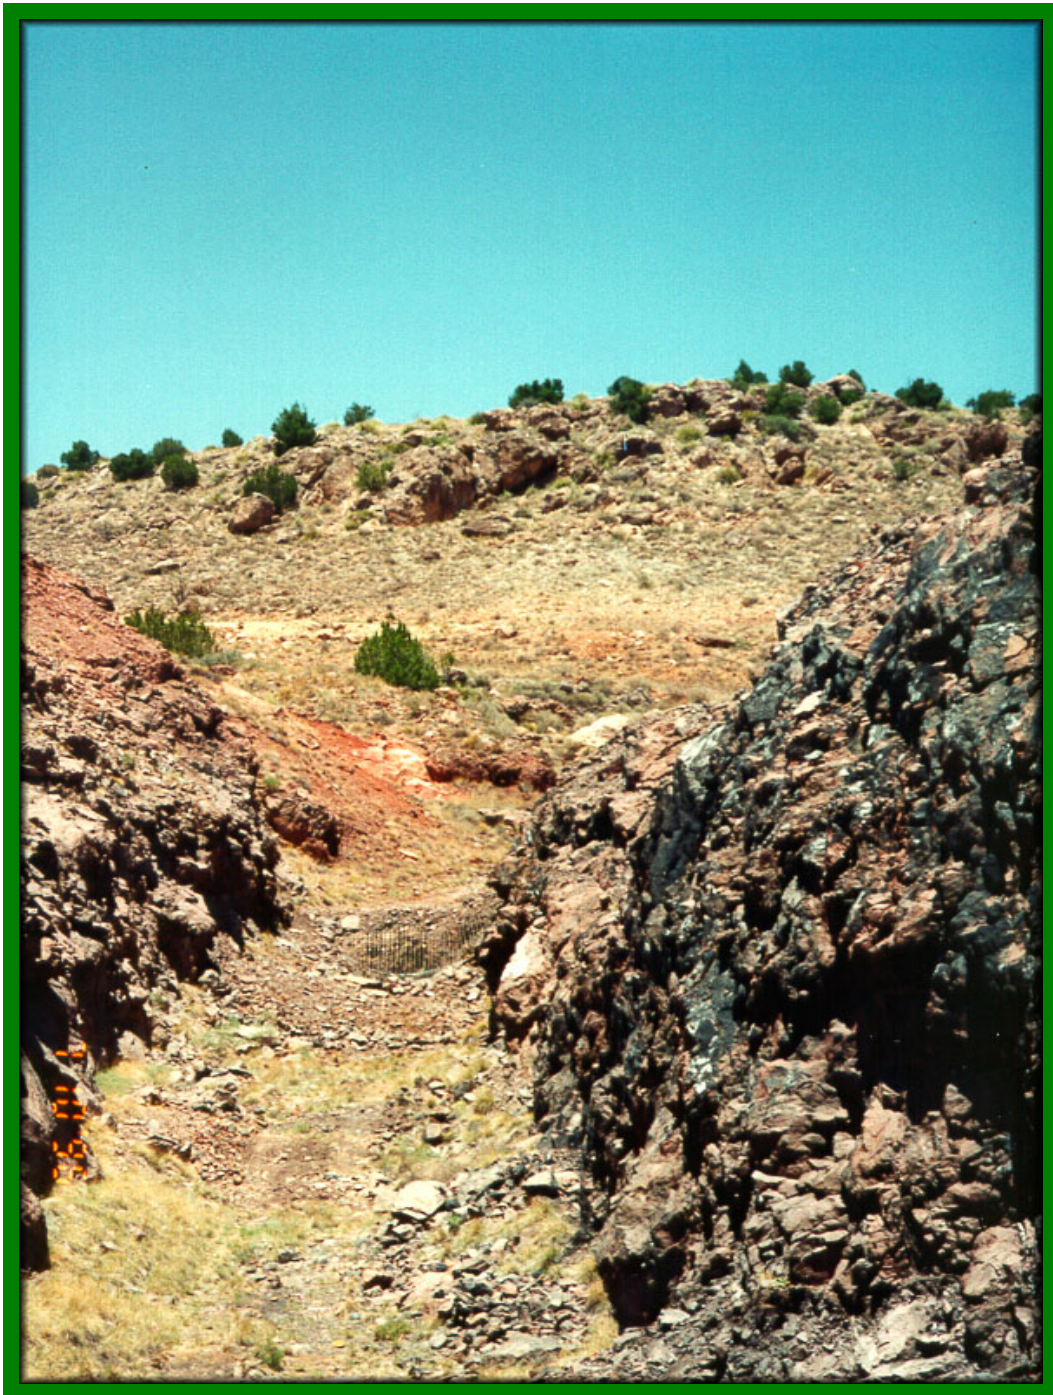
Completed cable net at the Feature 17 Open Stope, in middle of photo

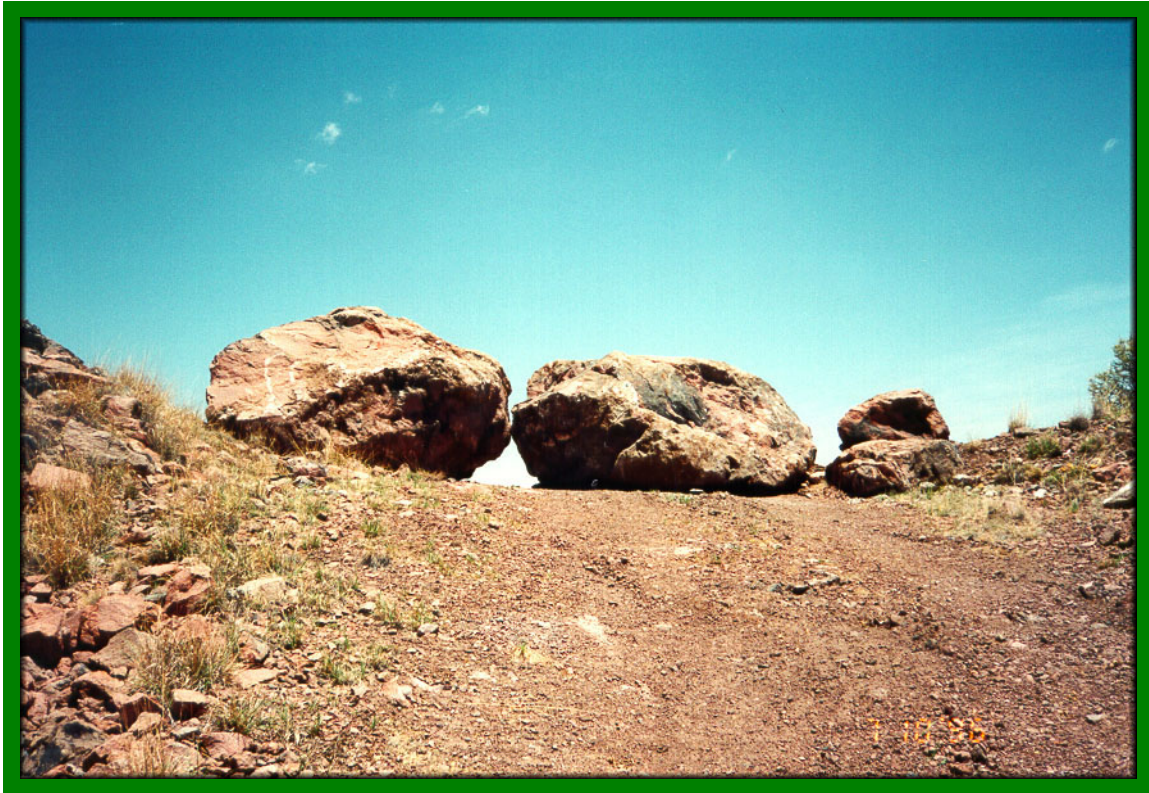
Rocks placed to block access road to the Feature 15 Shaft
